# **Executive Summary**

**12958 Hwy 27**

**Project number 24-162**

## **BUILDING CONDITION ASSESSMENT**

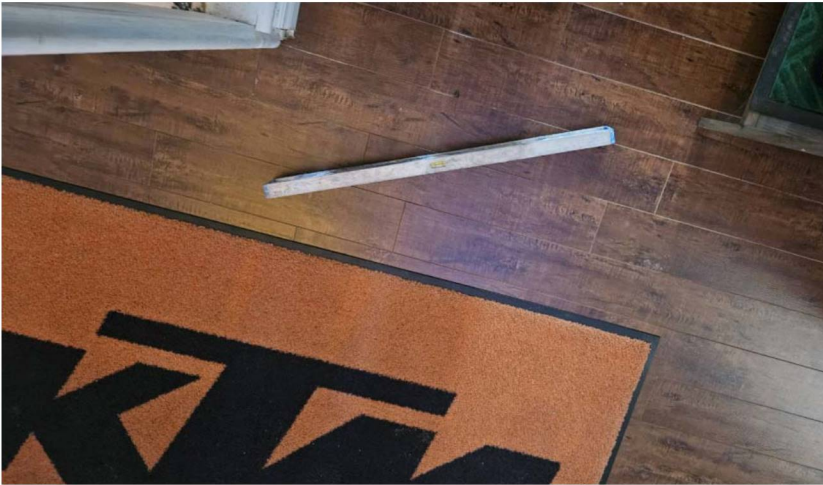
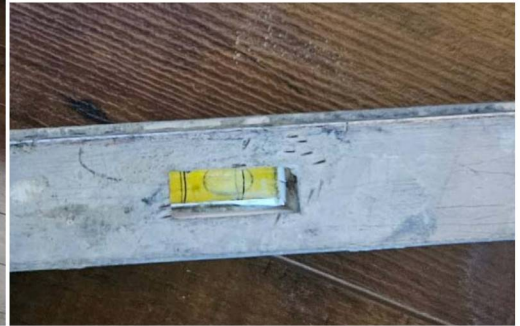
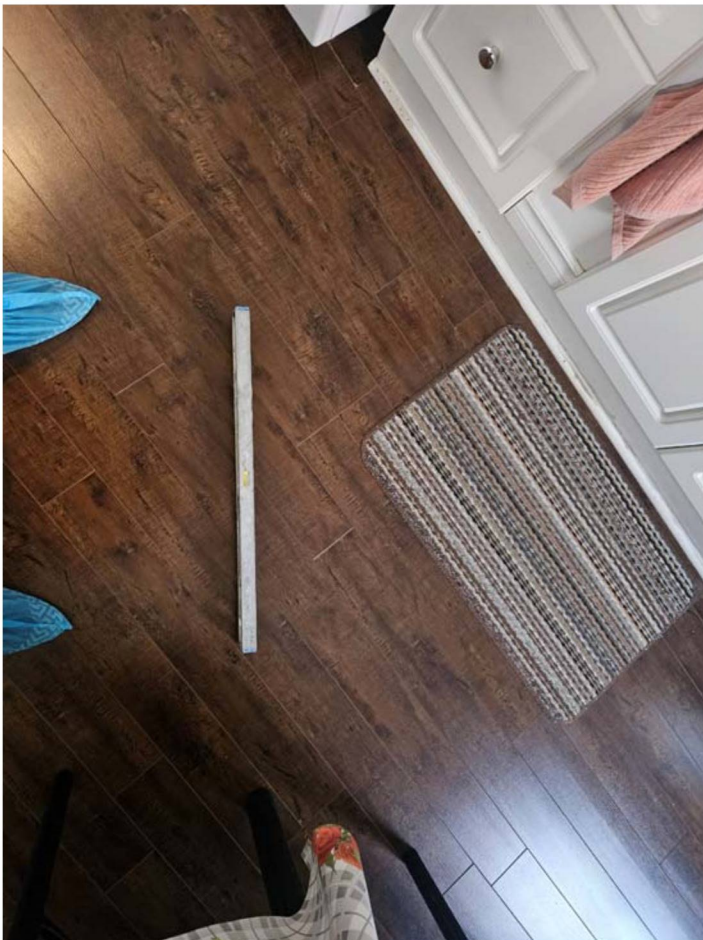
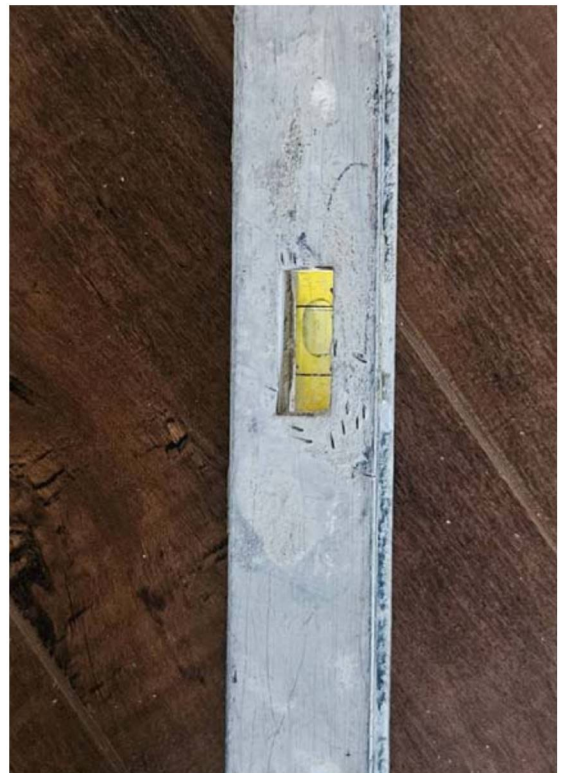
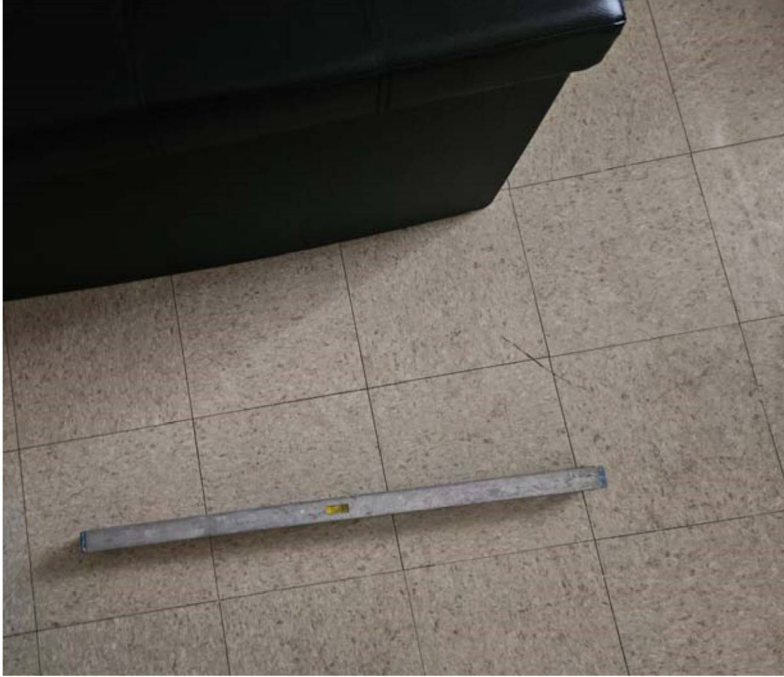
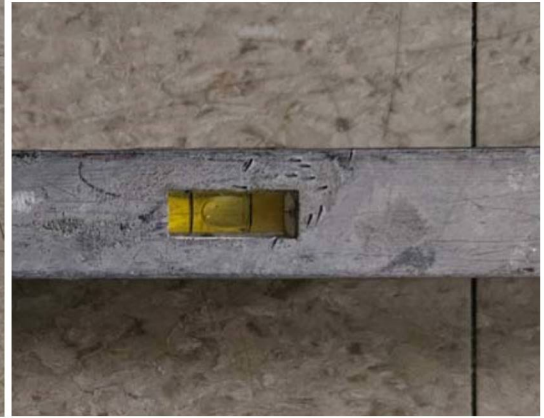
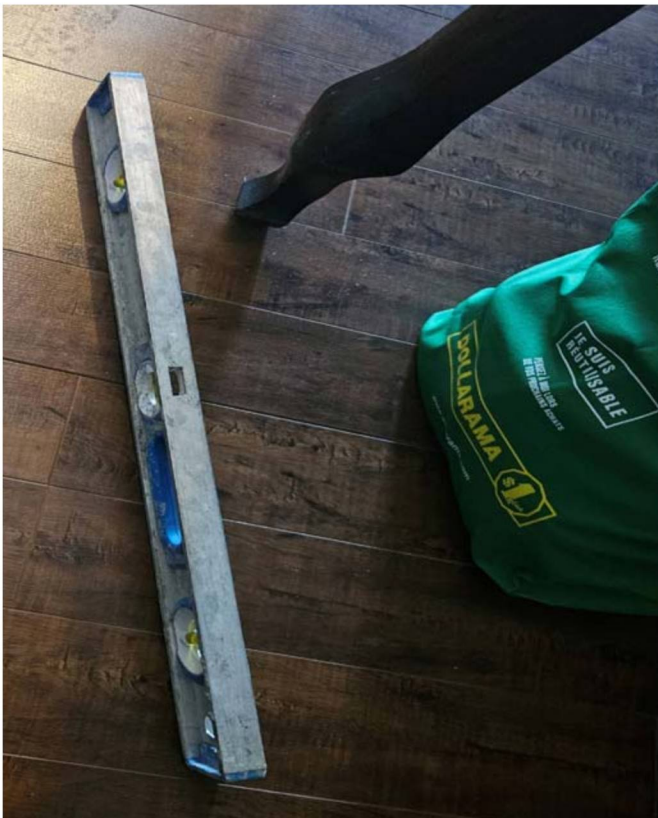
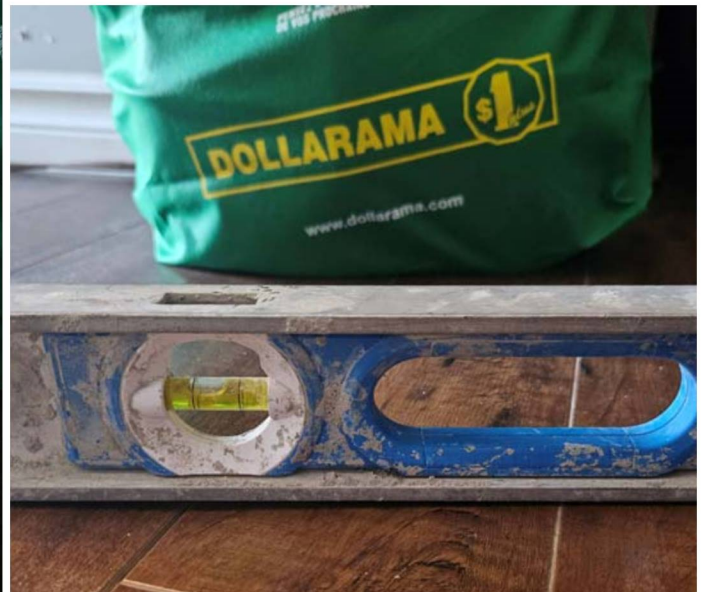
5. The presence of temporary shoring supports in the basement strongly suggests that the existing structural system lacks sufficient support.
6. The floors throughout the building are uneven and out of level, indicating possible settling or structural issues.

### Floors – Out of Level

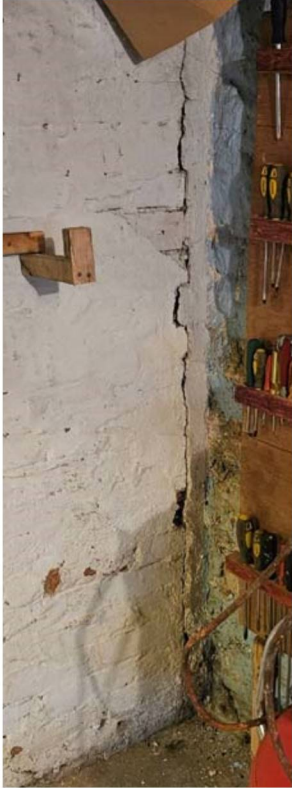
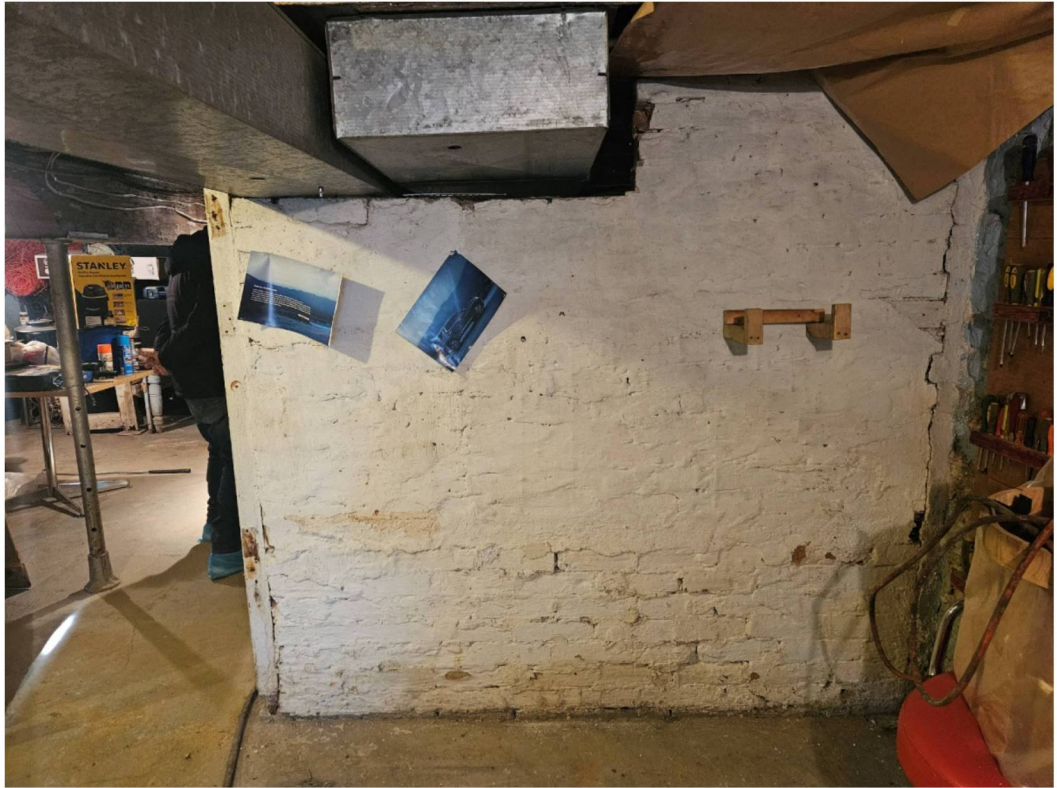
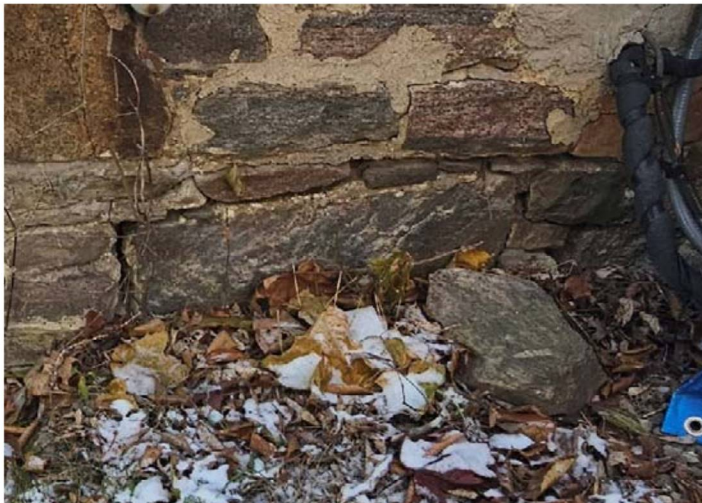
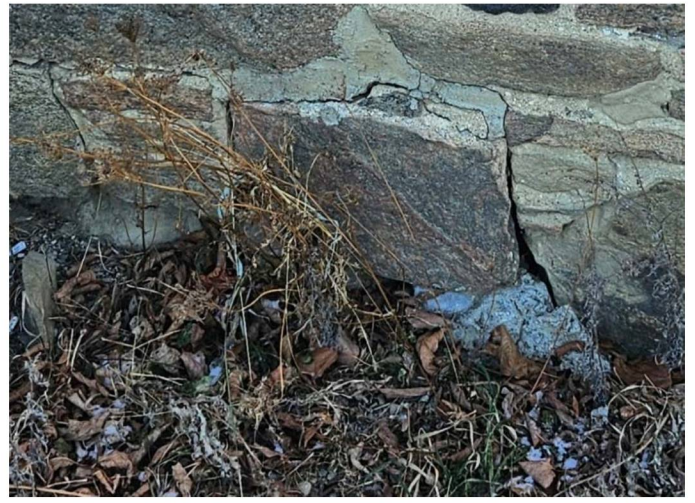
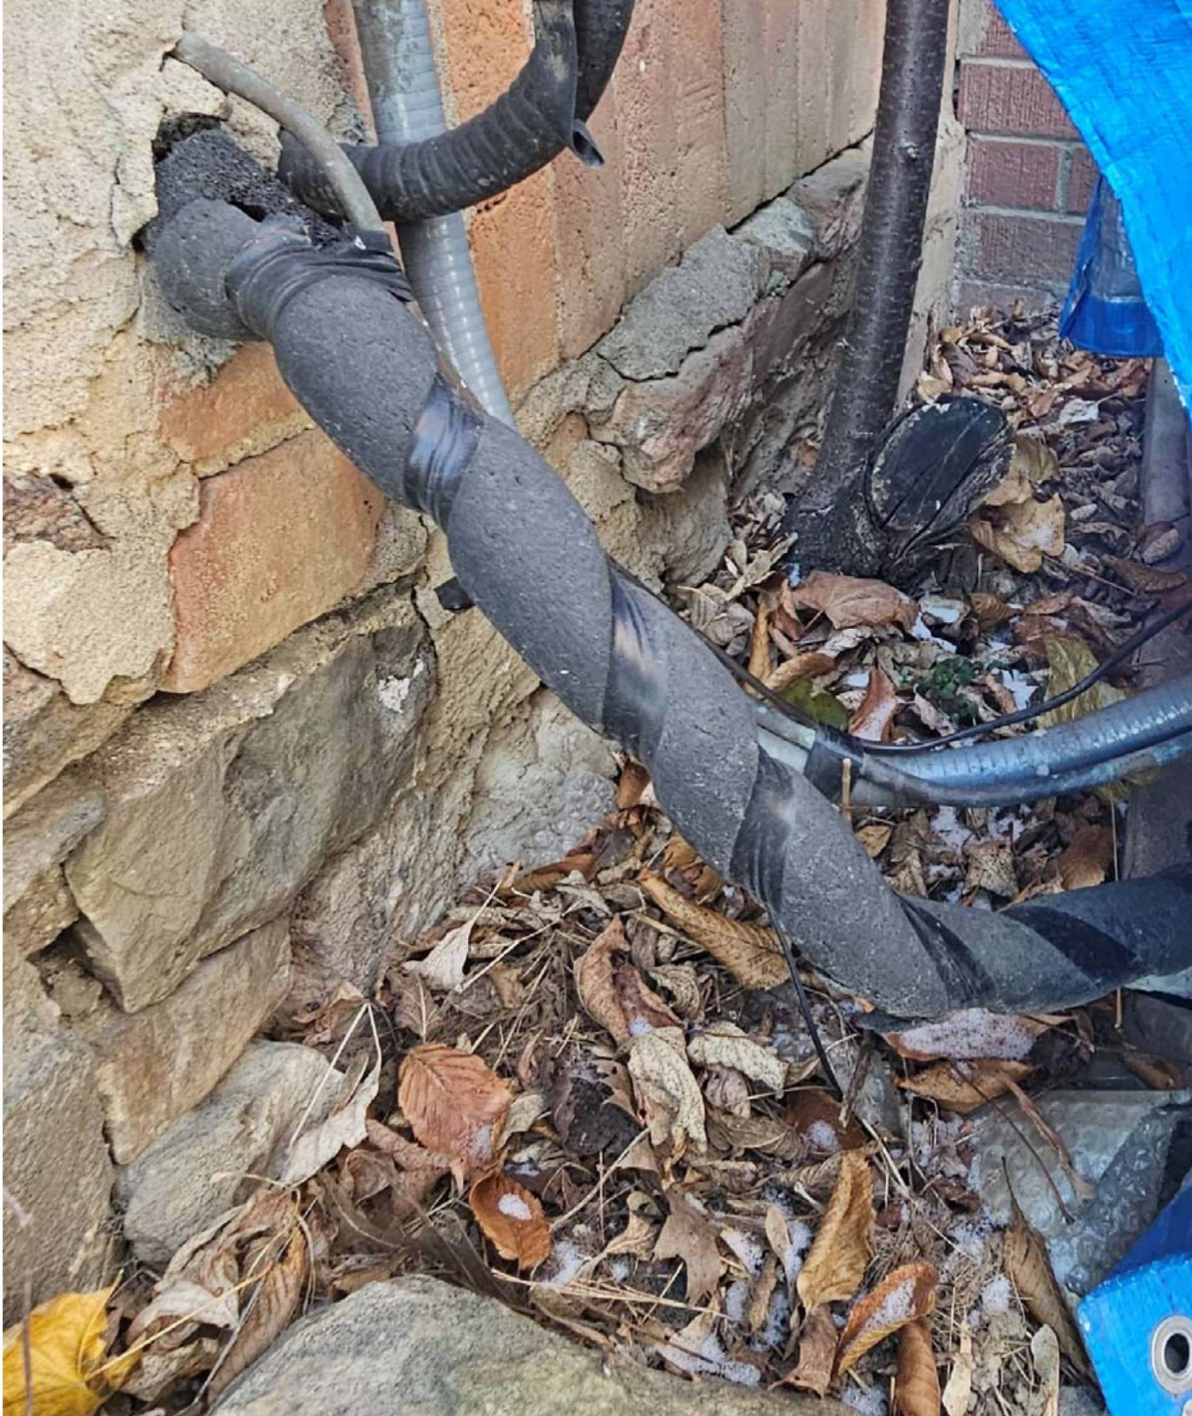
3. Major vertical cracks were found in the foundation wall, indicating that the foundation is not capable of adequately supporting the weight of the structure which may lead to significant stability issues.

### Deteriorating and cracked Foundation

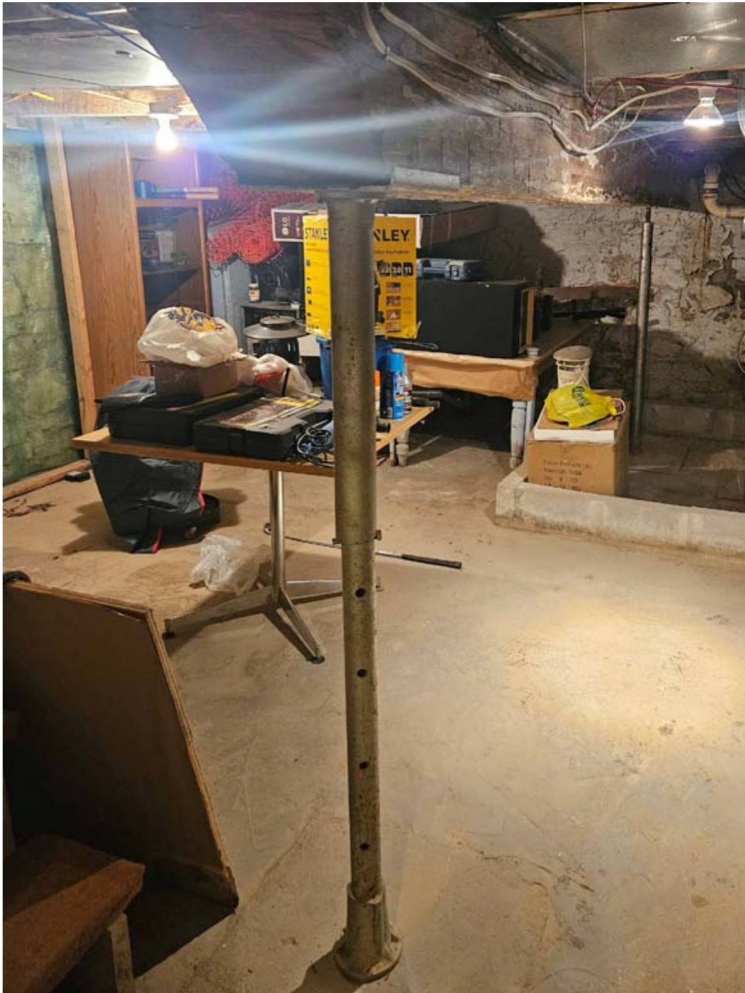
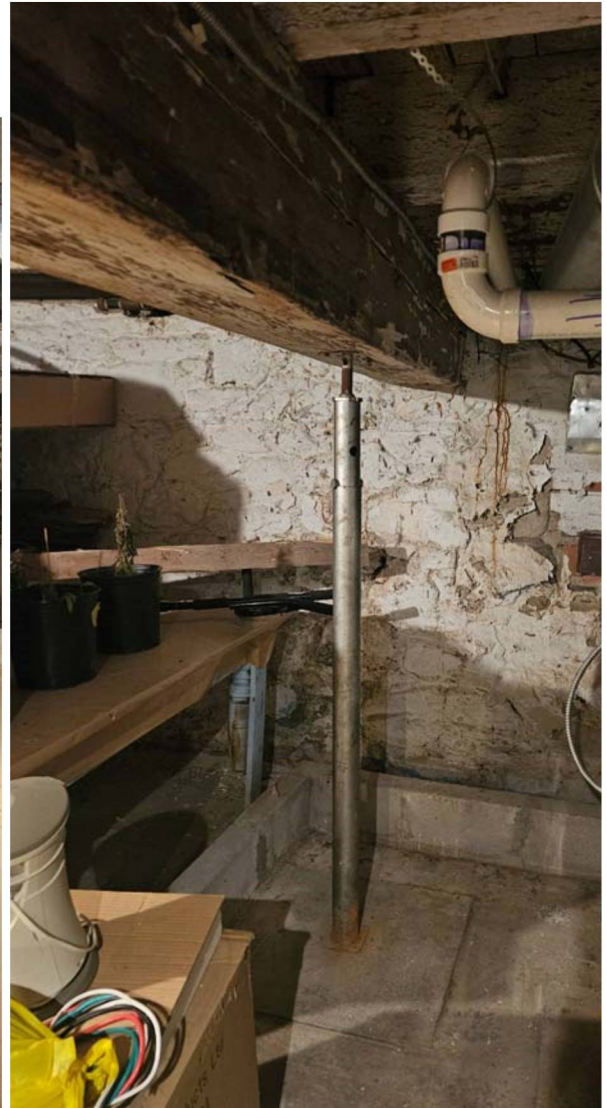
4. The basement does not contain permanently fixed columns or foundation pads, which are essential for ensuring the stability of the building. This absence may lead to shifting or settling of the structure over time. This matter requires immediate attention. We recommend demolition.

### Temporary Shoring provided for Additional Supports

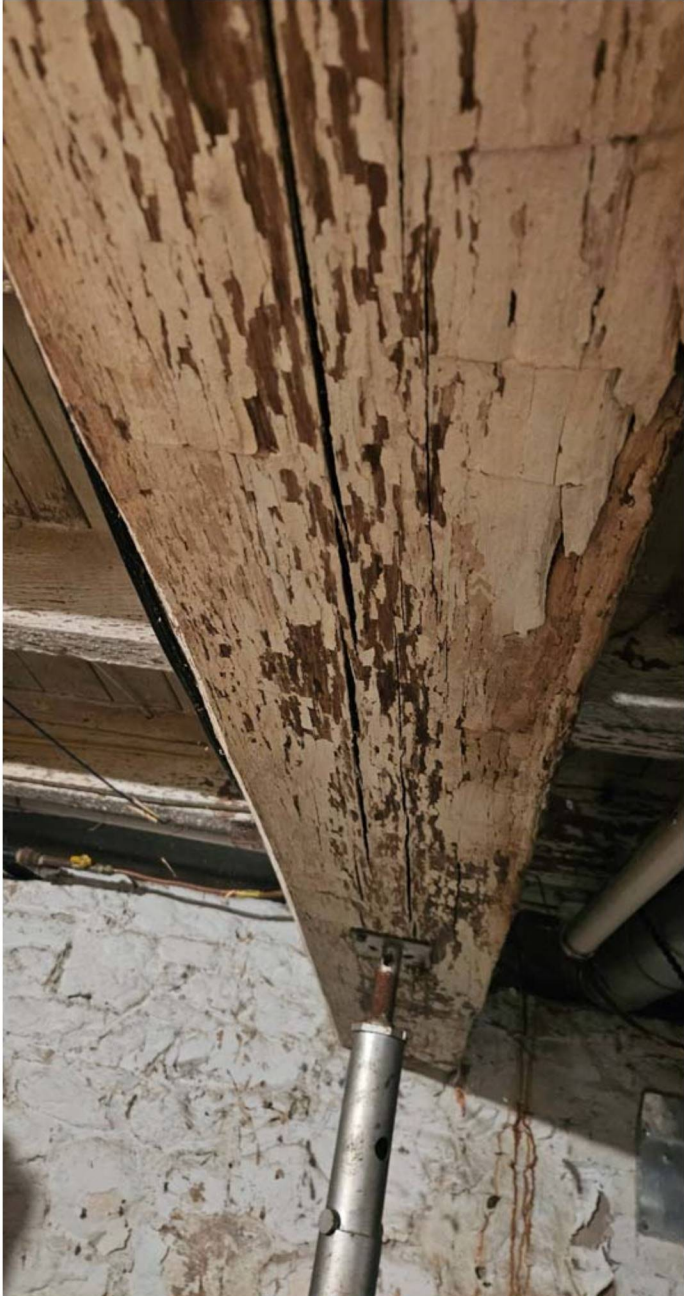
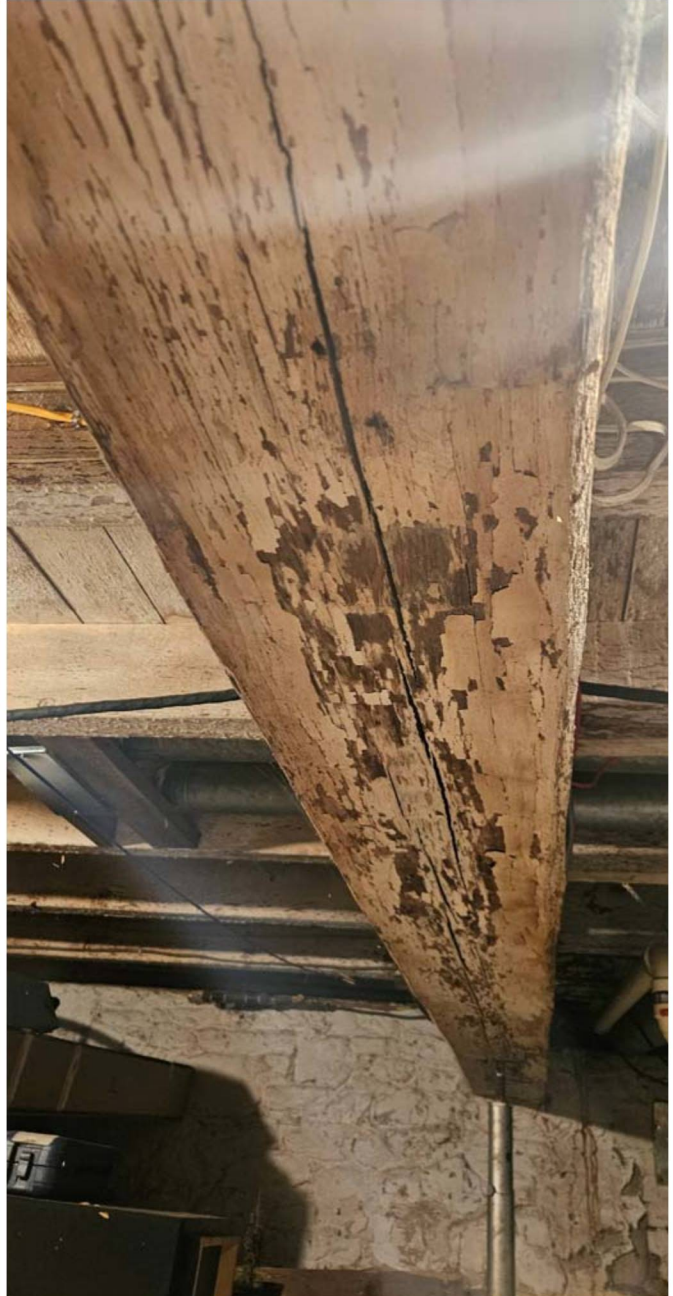
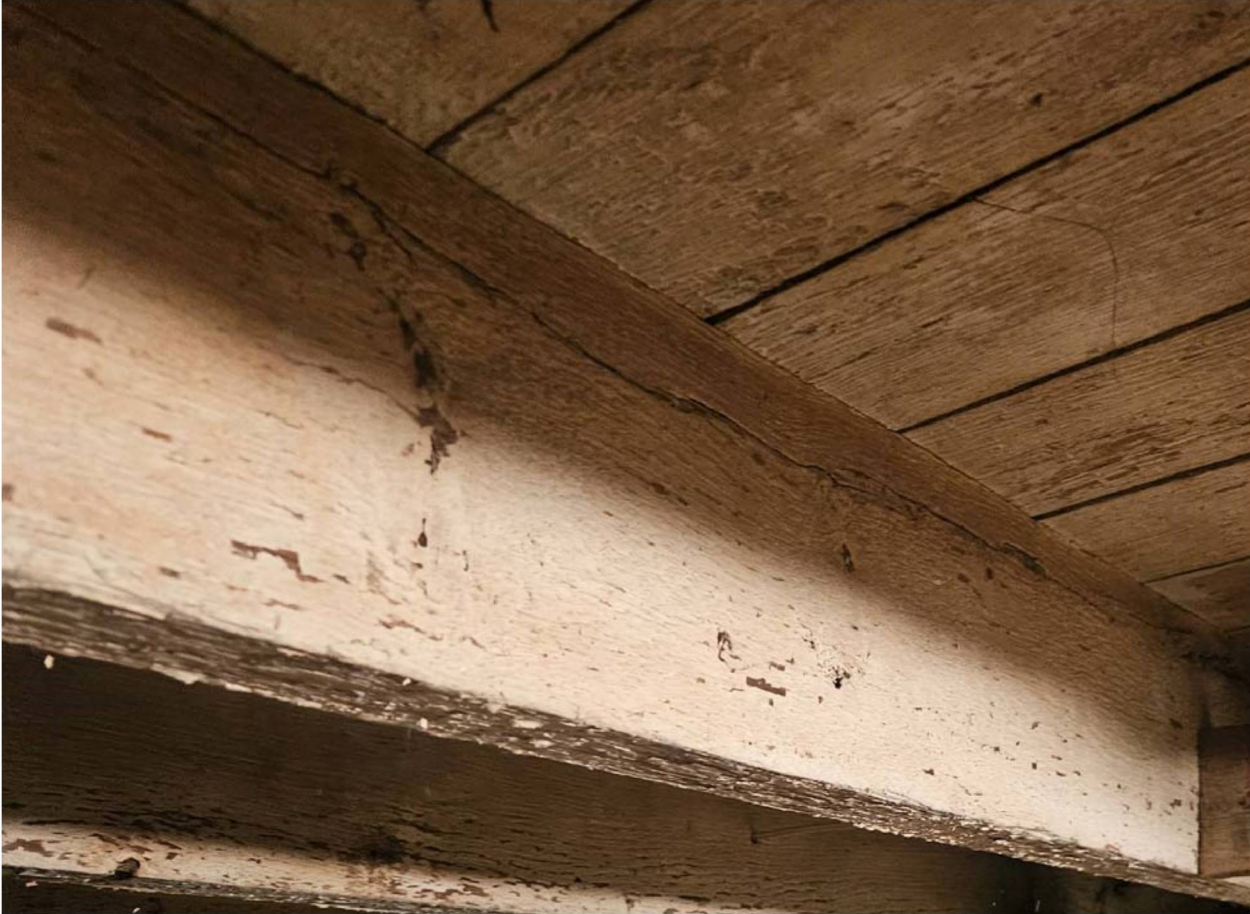
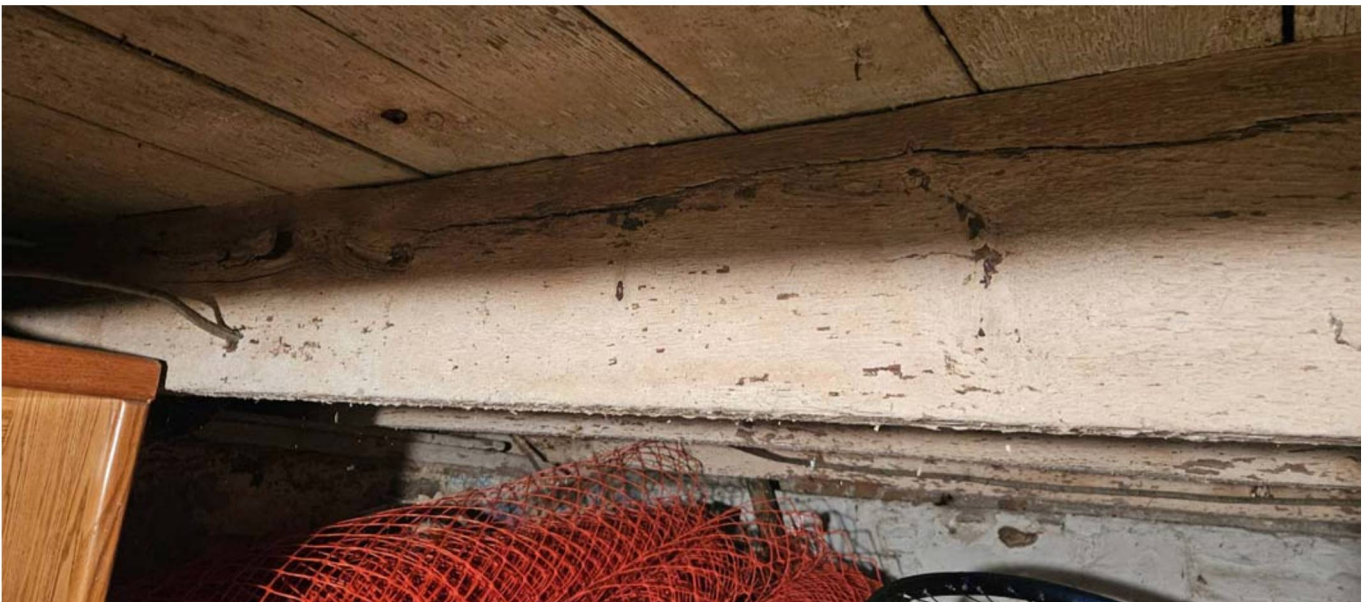
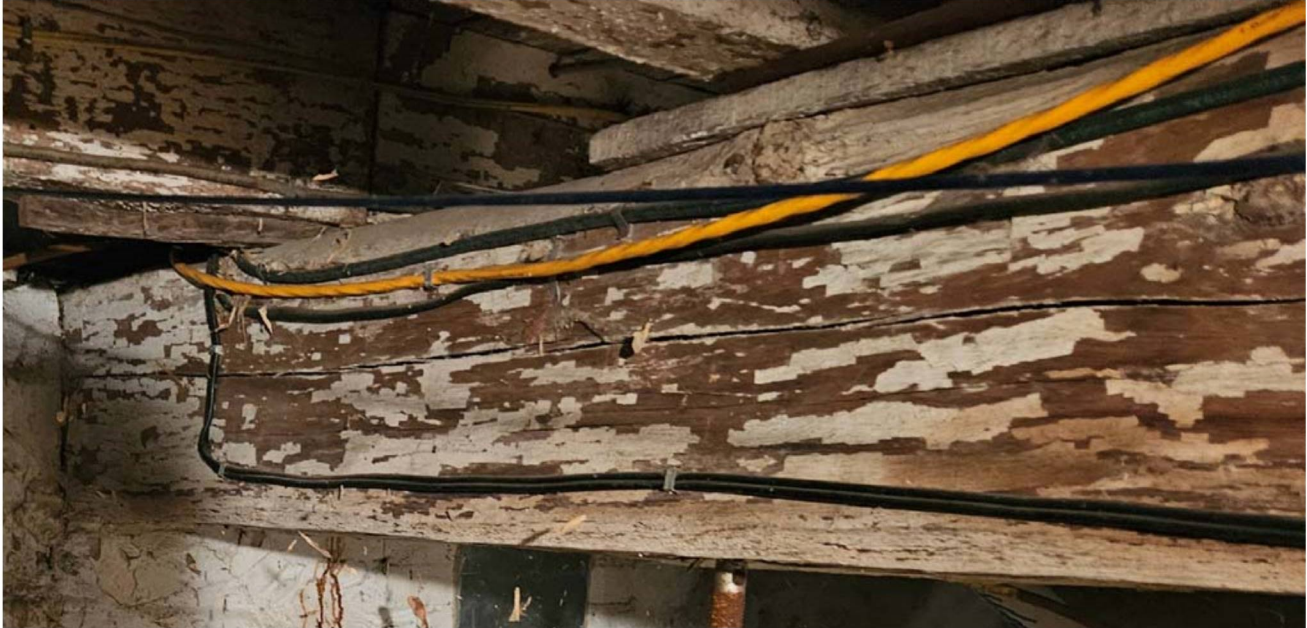
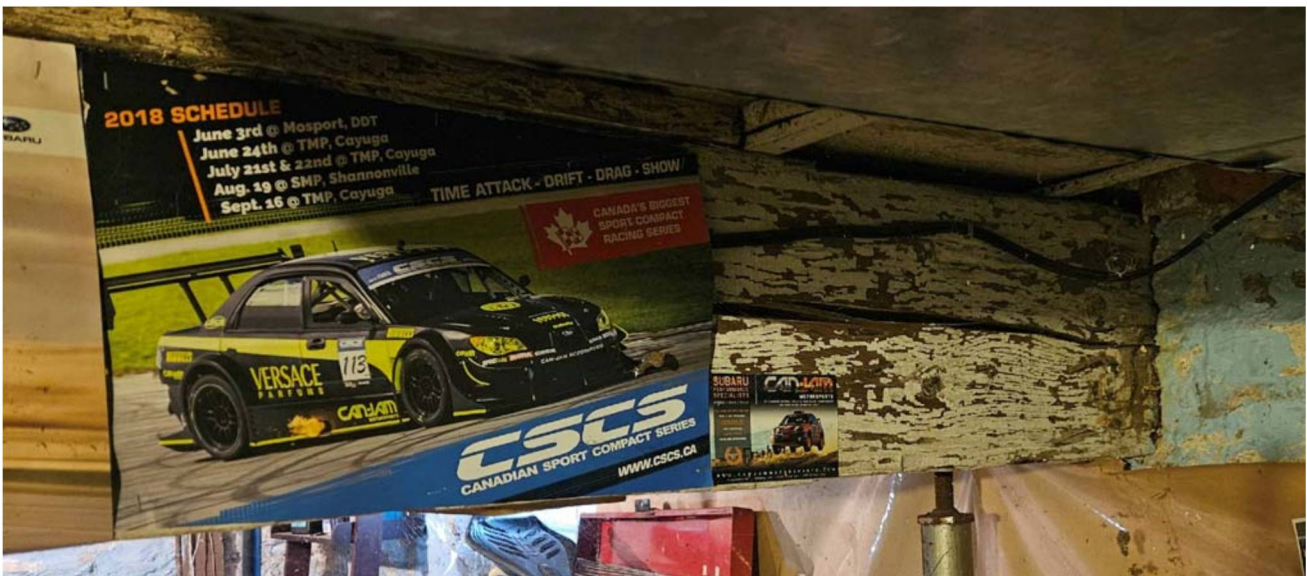
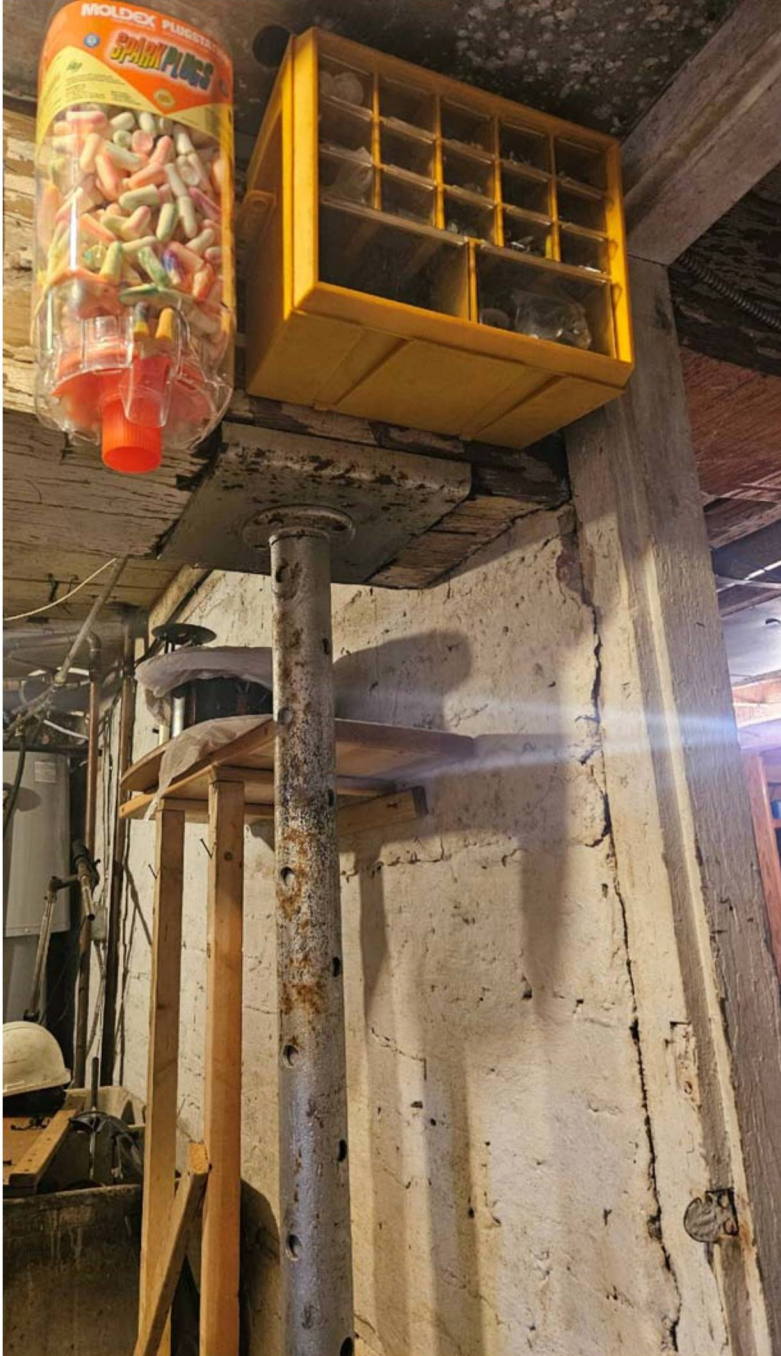
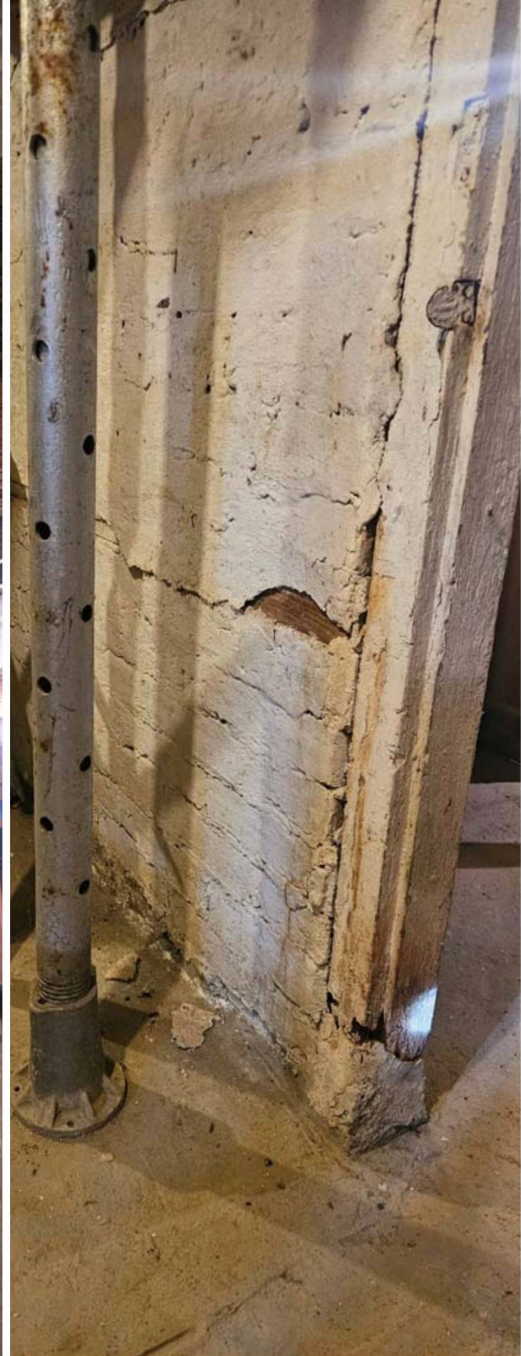
1. **The structural beams in the basement are split, severely compromising the structural integrity of the building. Immediate attention is required.**

### Damaged and Cracked Structural Elements

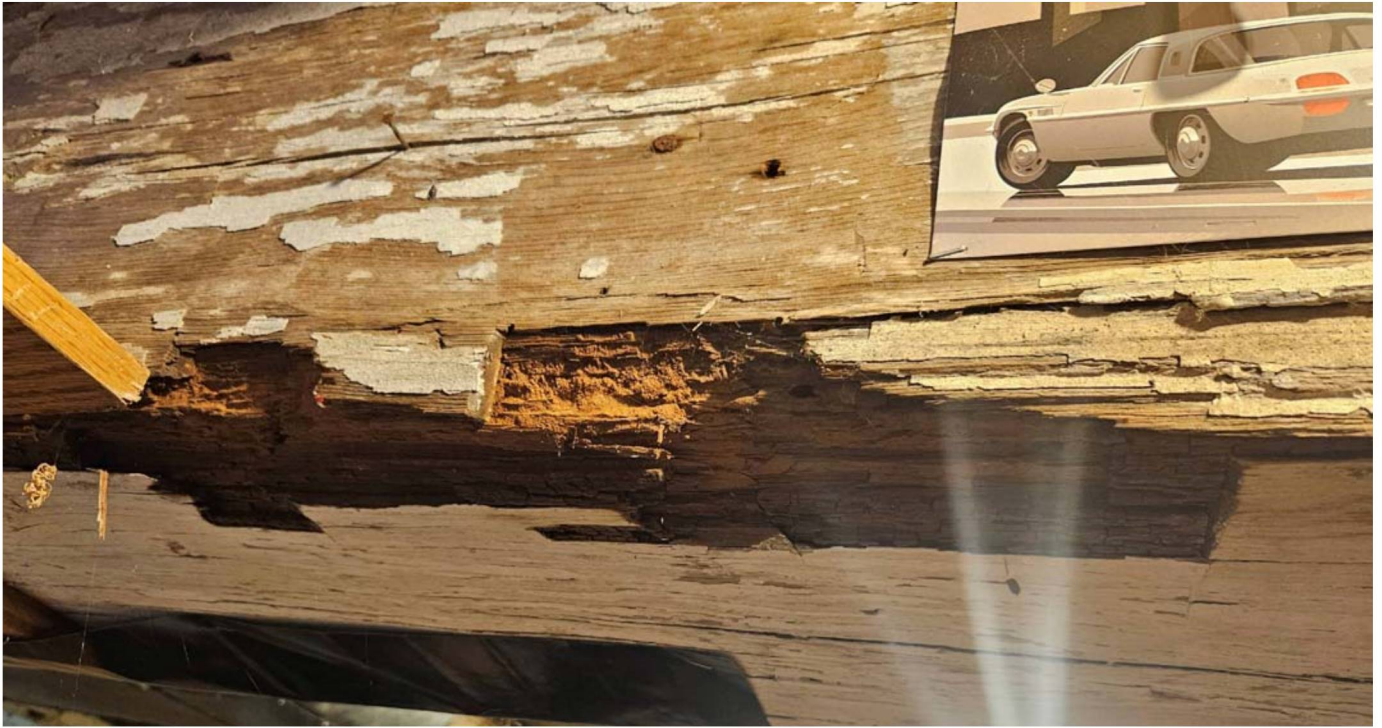
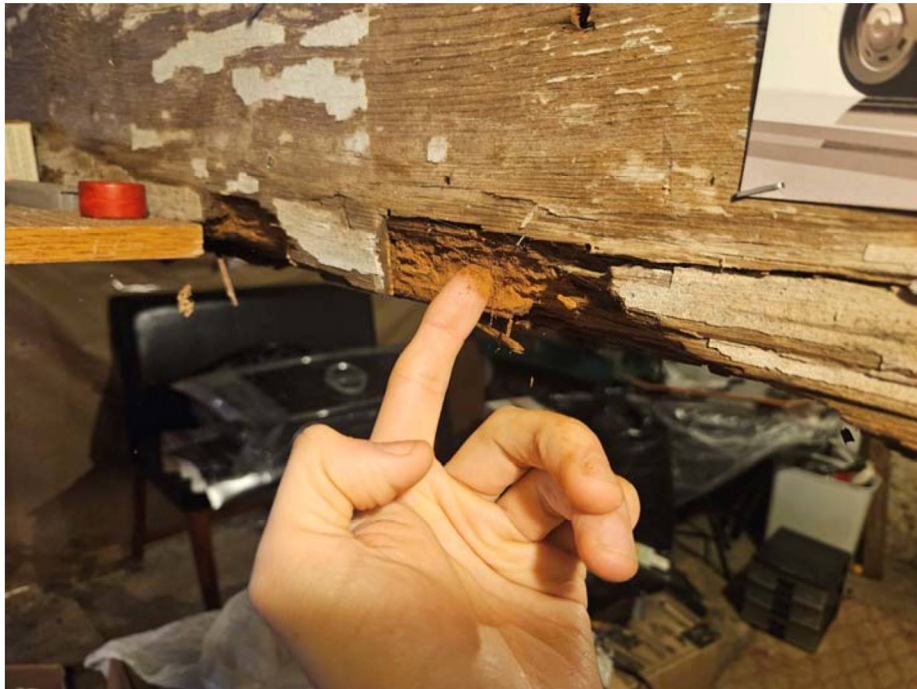
2. **The main support beams have significant termite infestation, severely weakening their structural integrity and compromising safety. This could result in immediate collapse. The extent of infestation throughout the dwelling is not known. Immediate attention to this matter and therefore we recommend demolition.**

### Termite Infested Structural Beam

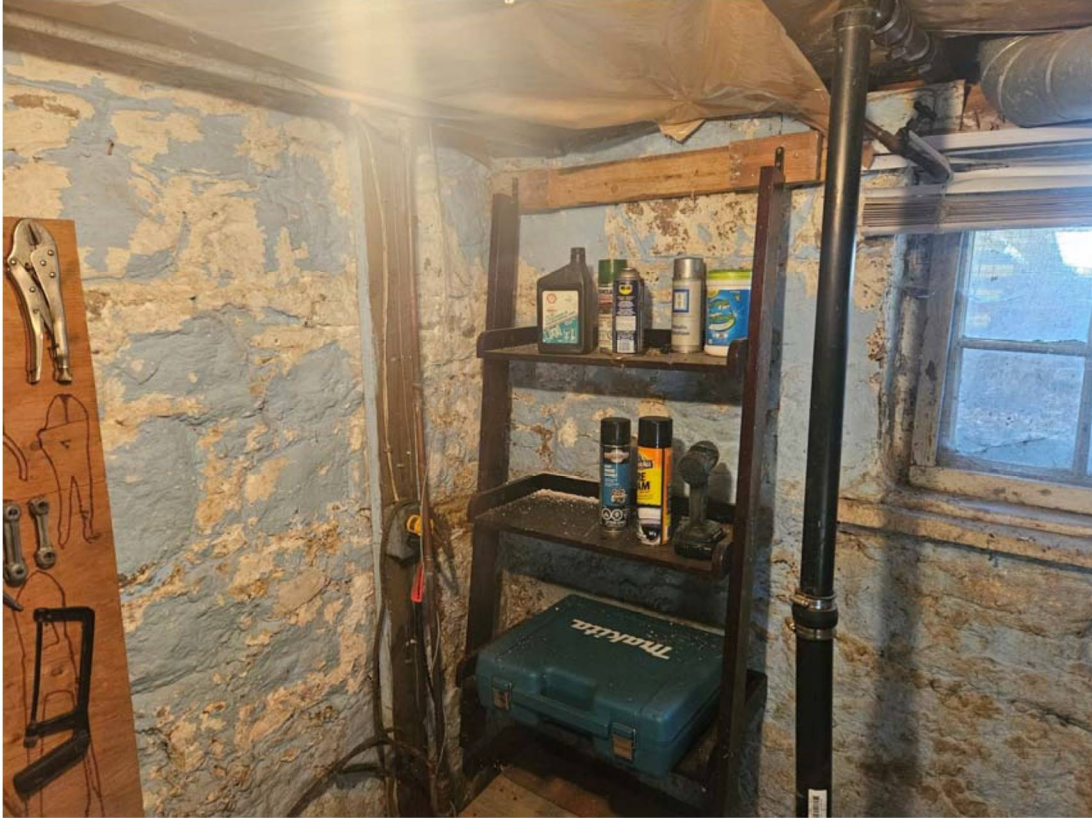
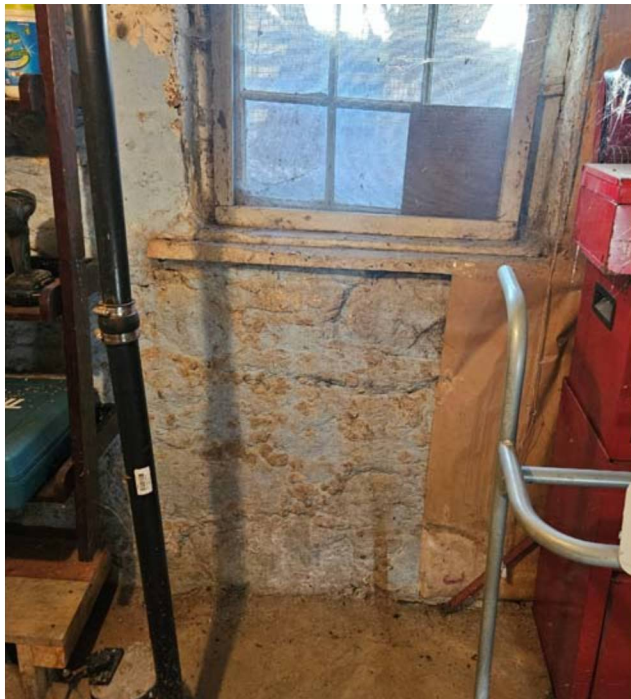
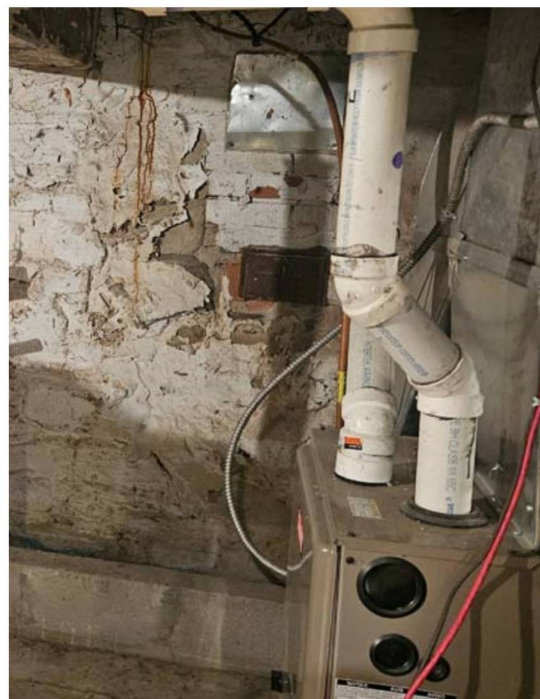
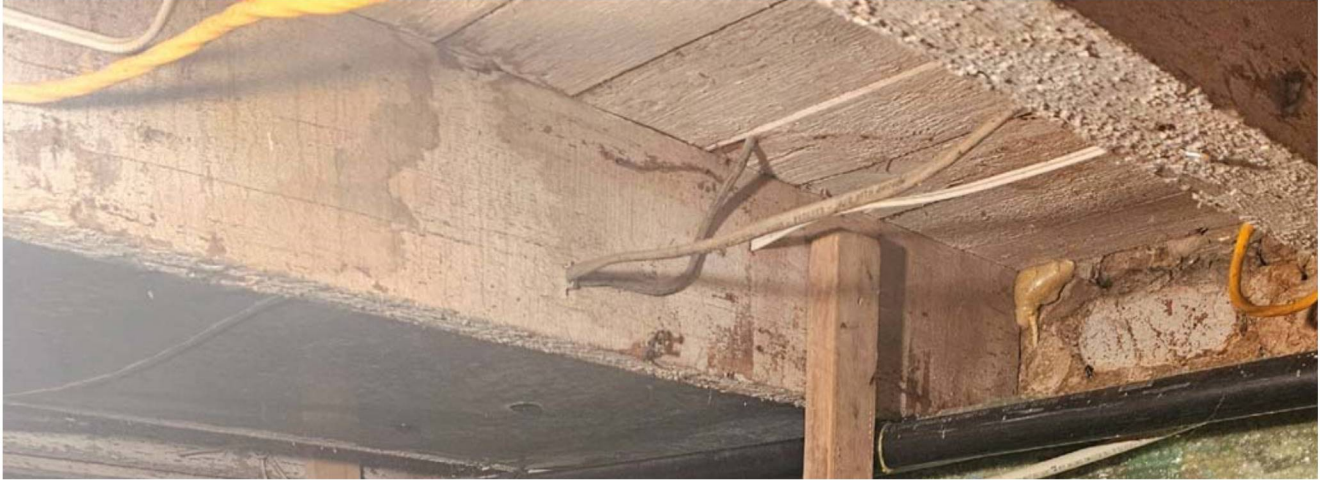
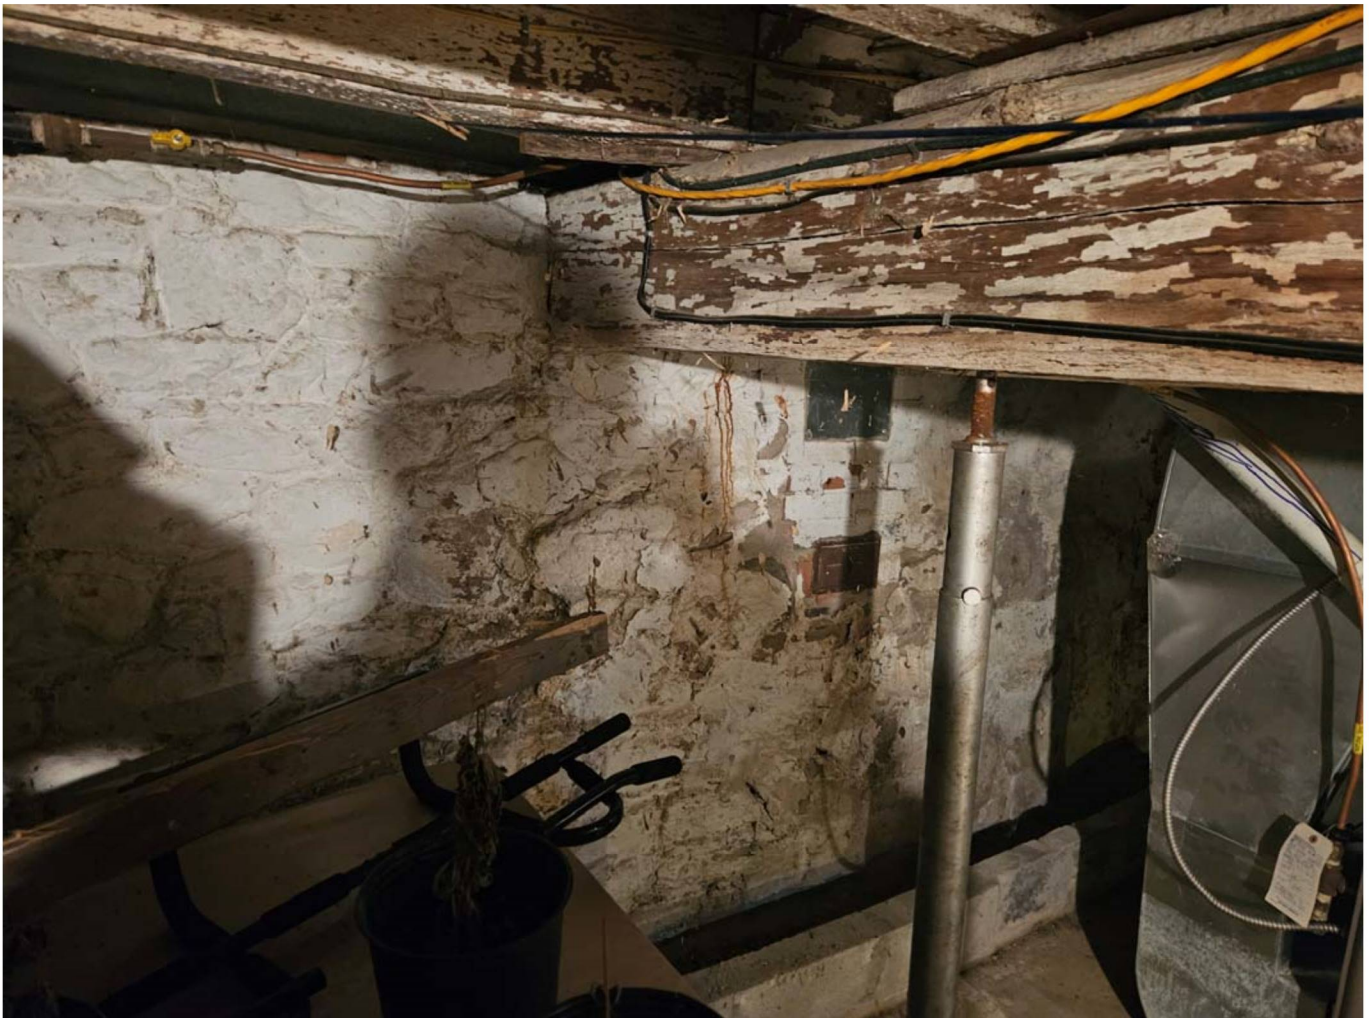
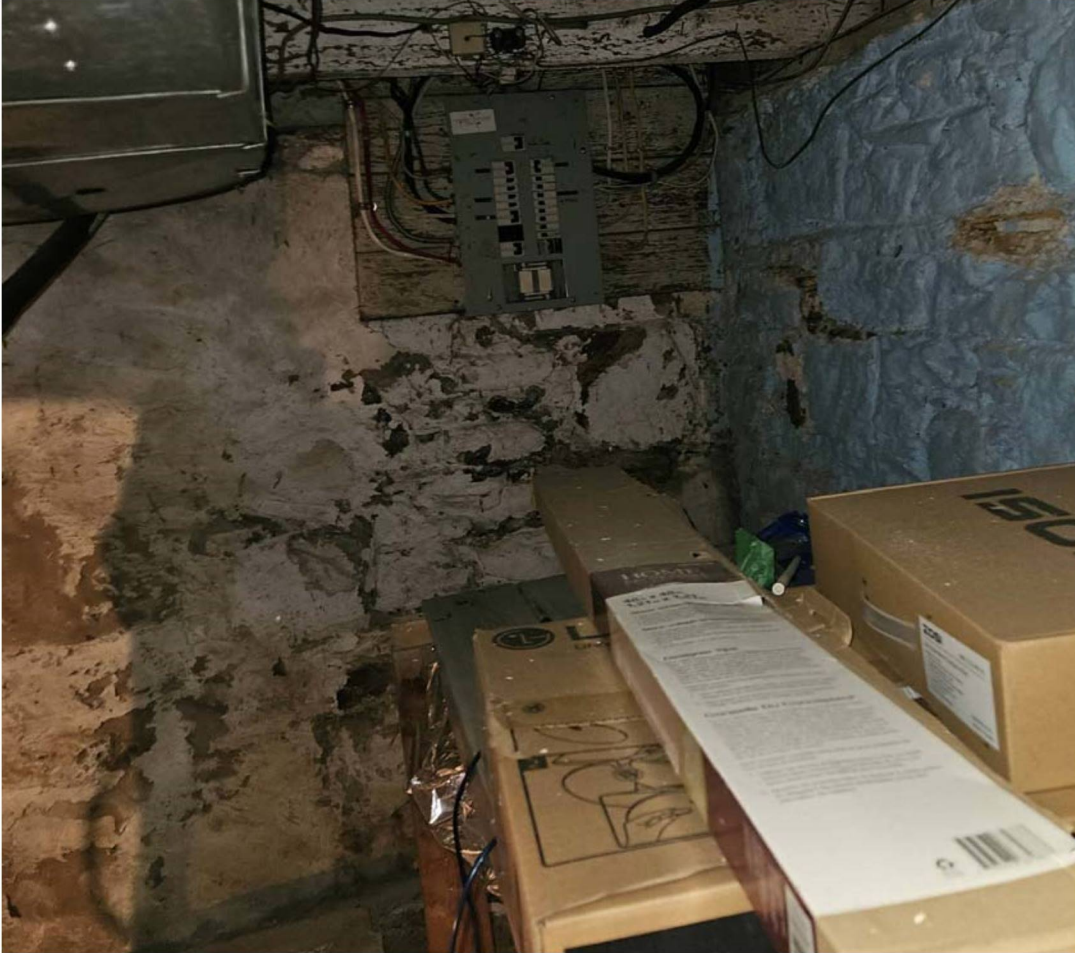
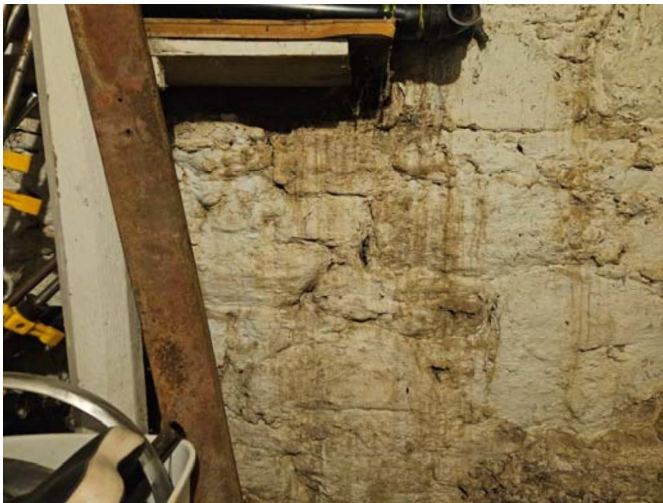
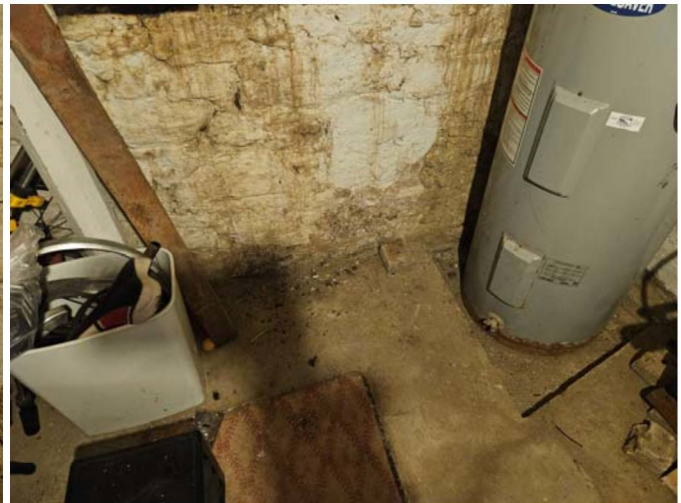
12. Water infiltration was found into the basement, likely causing damage to the foundation, walls, and materials
13. Worn and cracked masonry in various areas indicates the masonry's inability to support the building's load and exposure to weathering and water damage.

14. Foundation does not appear to be waterproofed. As a result, water is allowed to enter the building, leading to potential moisture-related issues such as mold growth, weakening of materials, and possible structural damage.

### Water Infiltration
