# **Executive Summary**

**12958 Hwy 27**

**Project number 24-162**

## **BUILDING CONDITION ASSESSMENT**

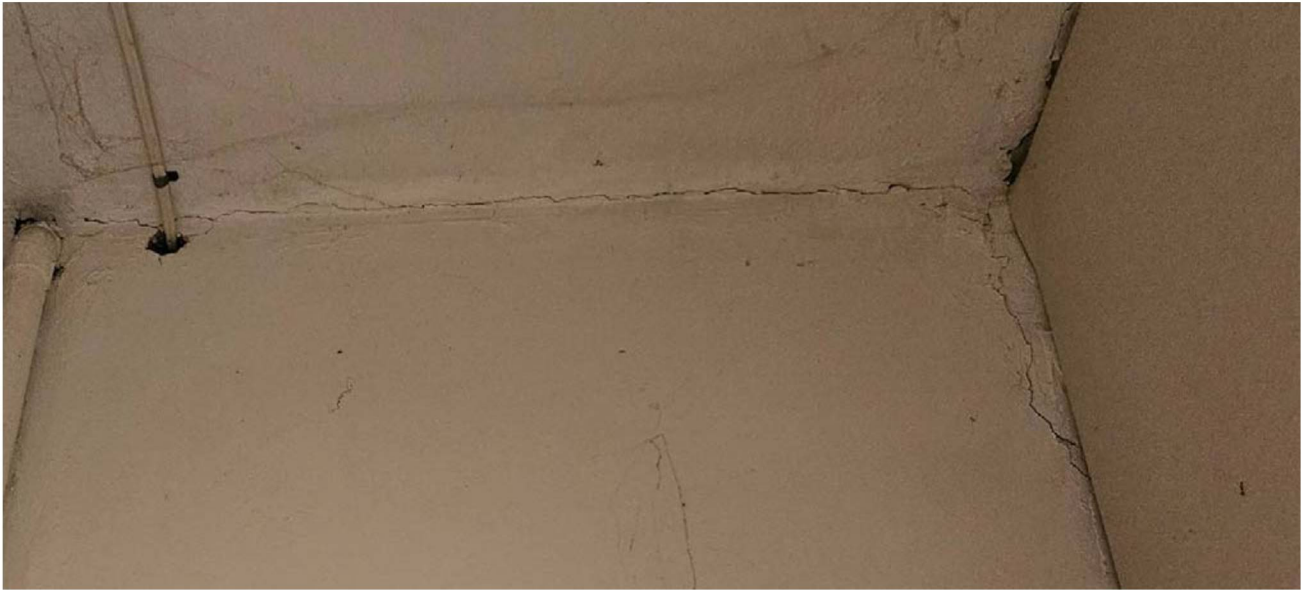
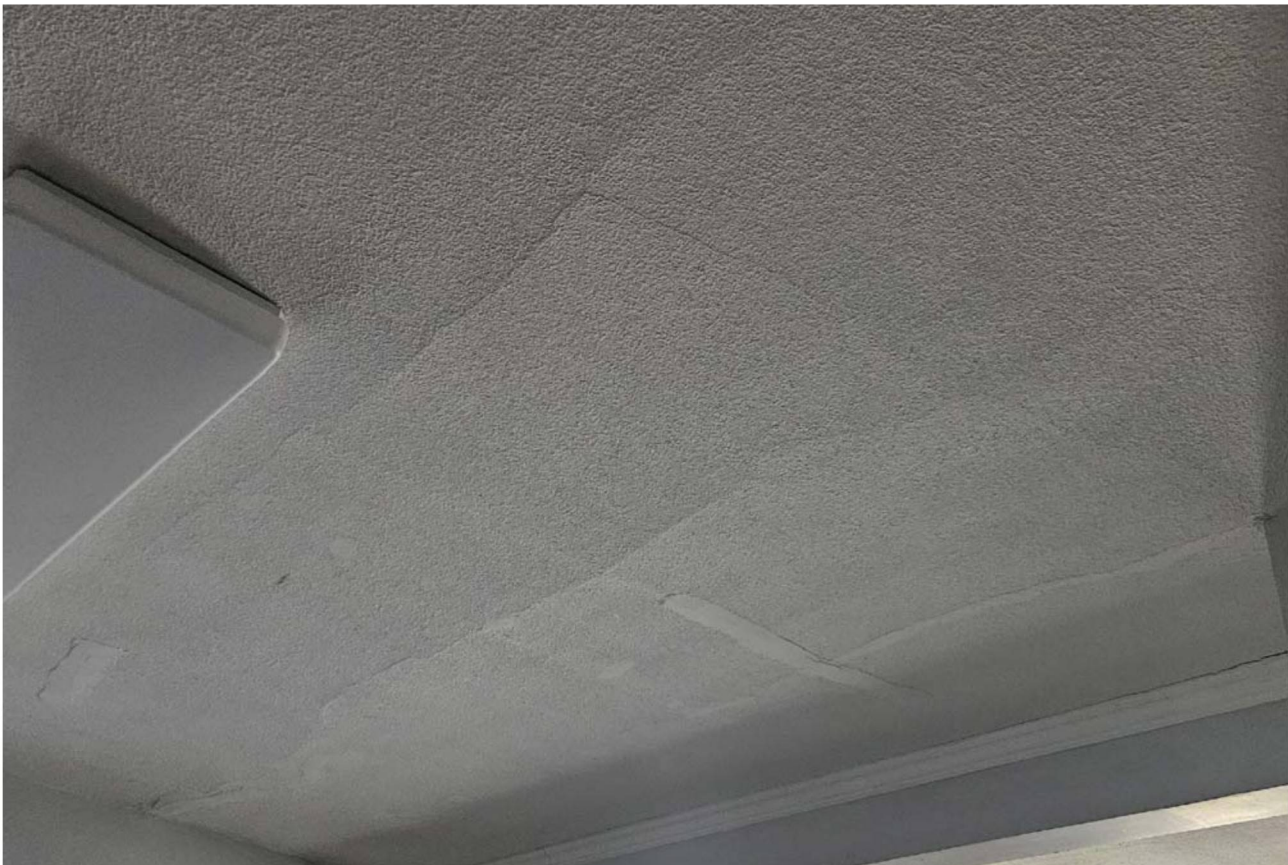
### Ceiling Cracked and Spalling

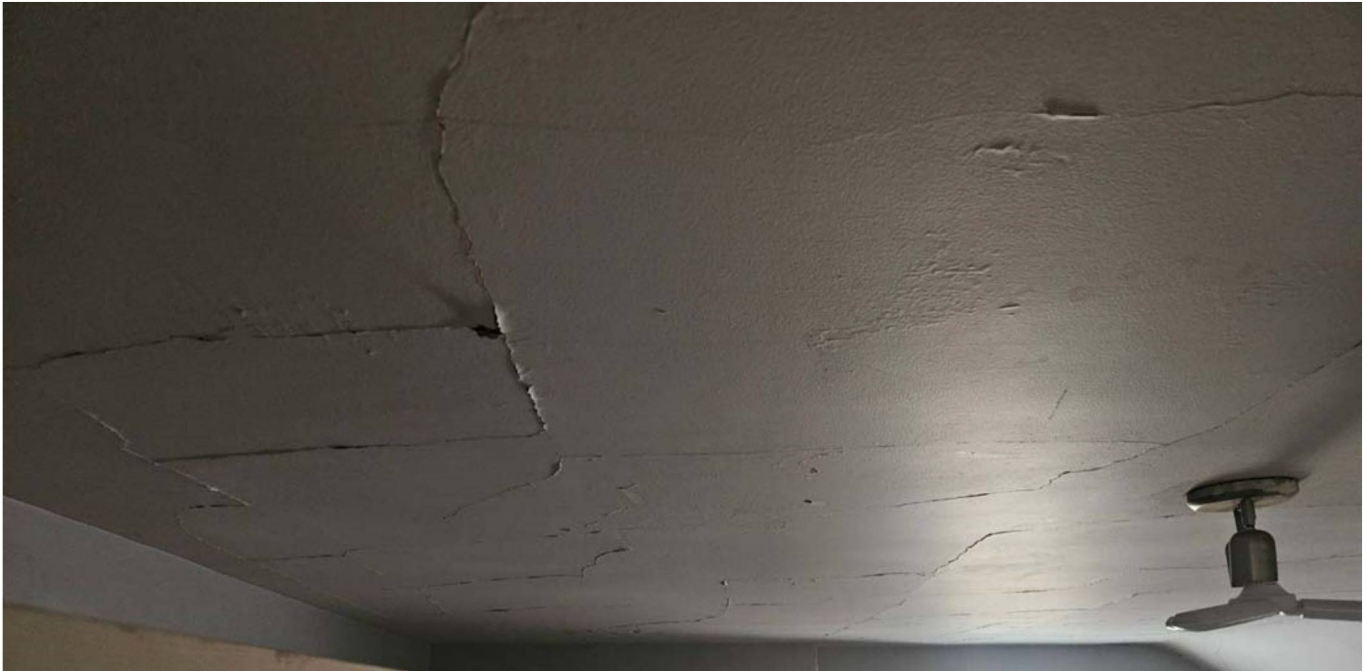
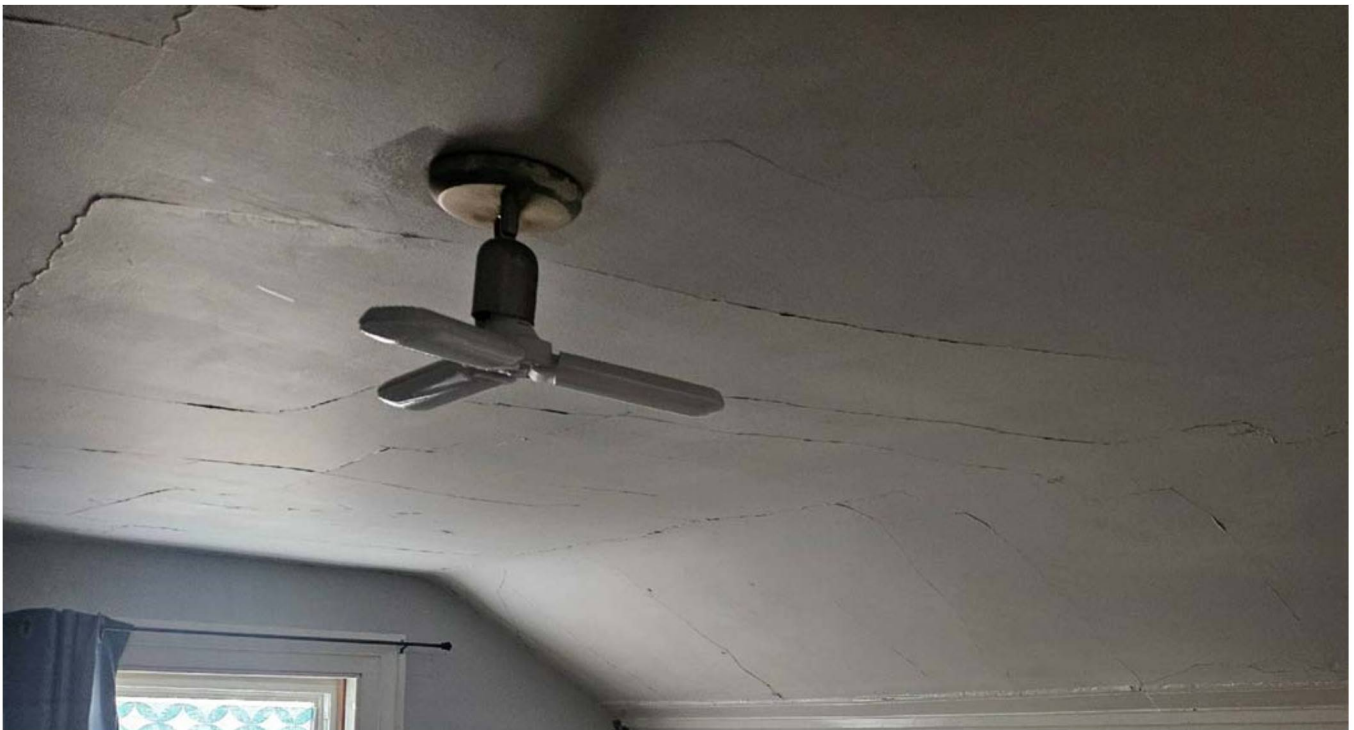
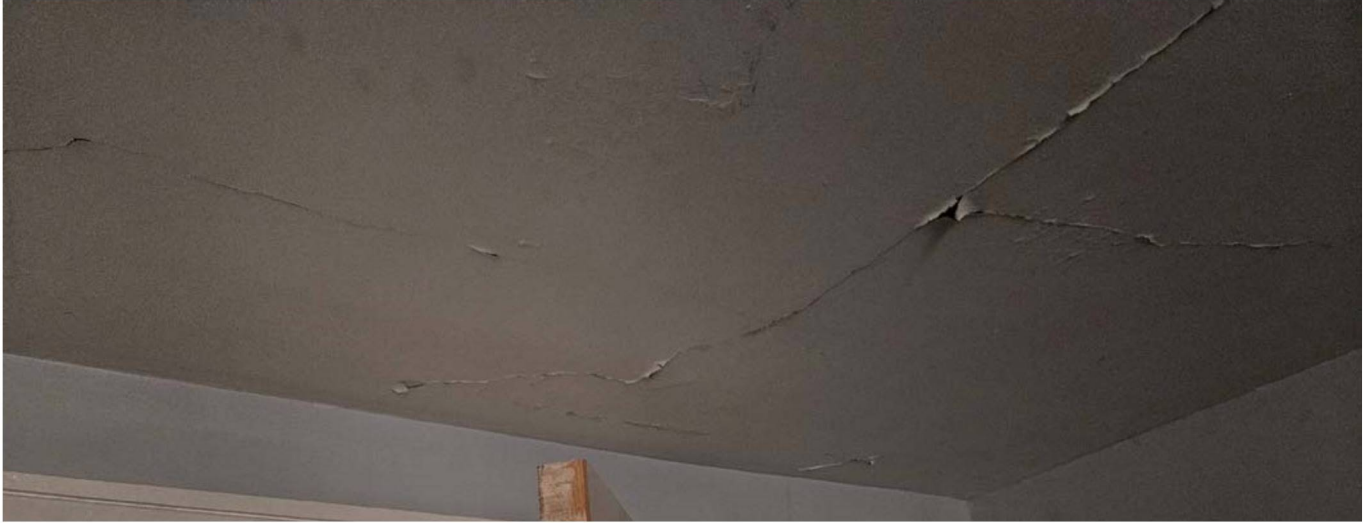
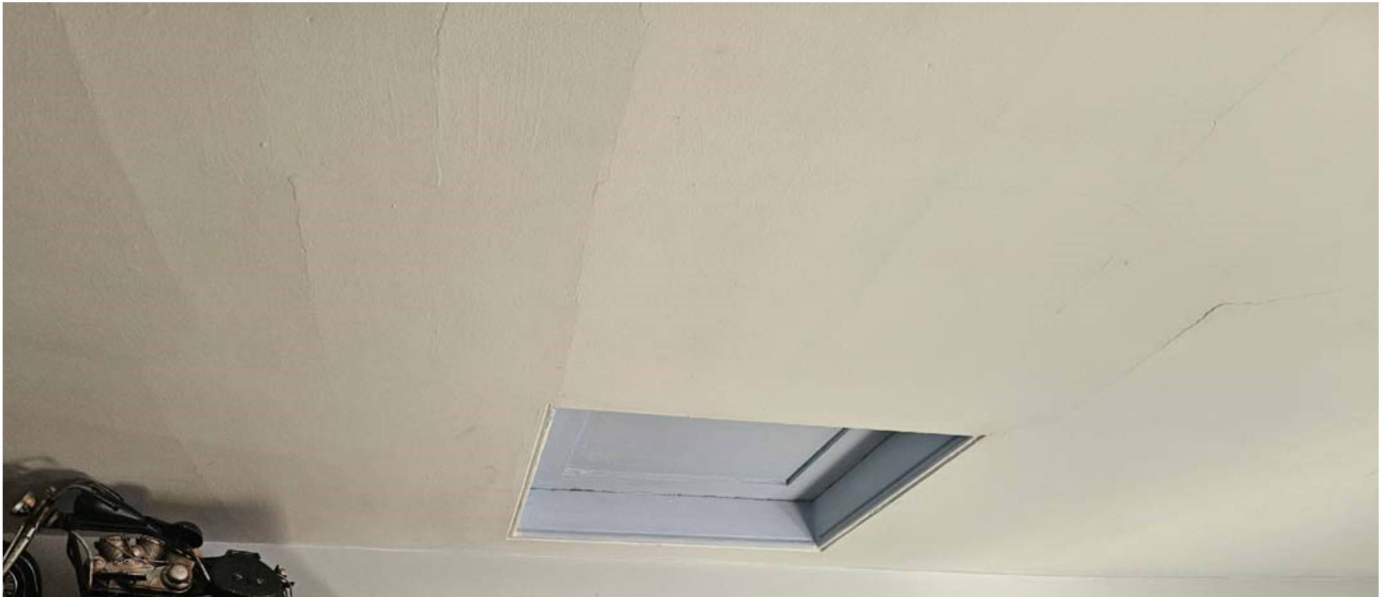
5. Multiple sections of the ceiling throughout the dwelling have cracked and deflected, which poses a serious safety hazard. The condition of the ceiling suggests water damage and the potential for mold growth. This structural issue may also indicate shifting of the overall building structure, requiring immediate attention to ensure safety and stability.

### **Ceilings Cracked indication water infiltration and structure settlement**

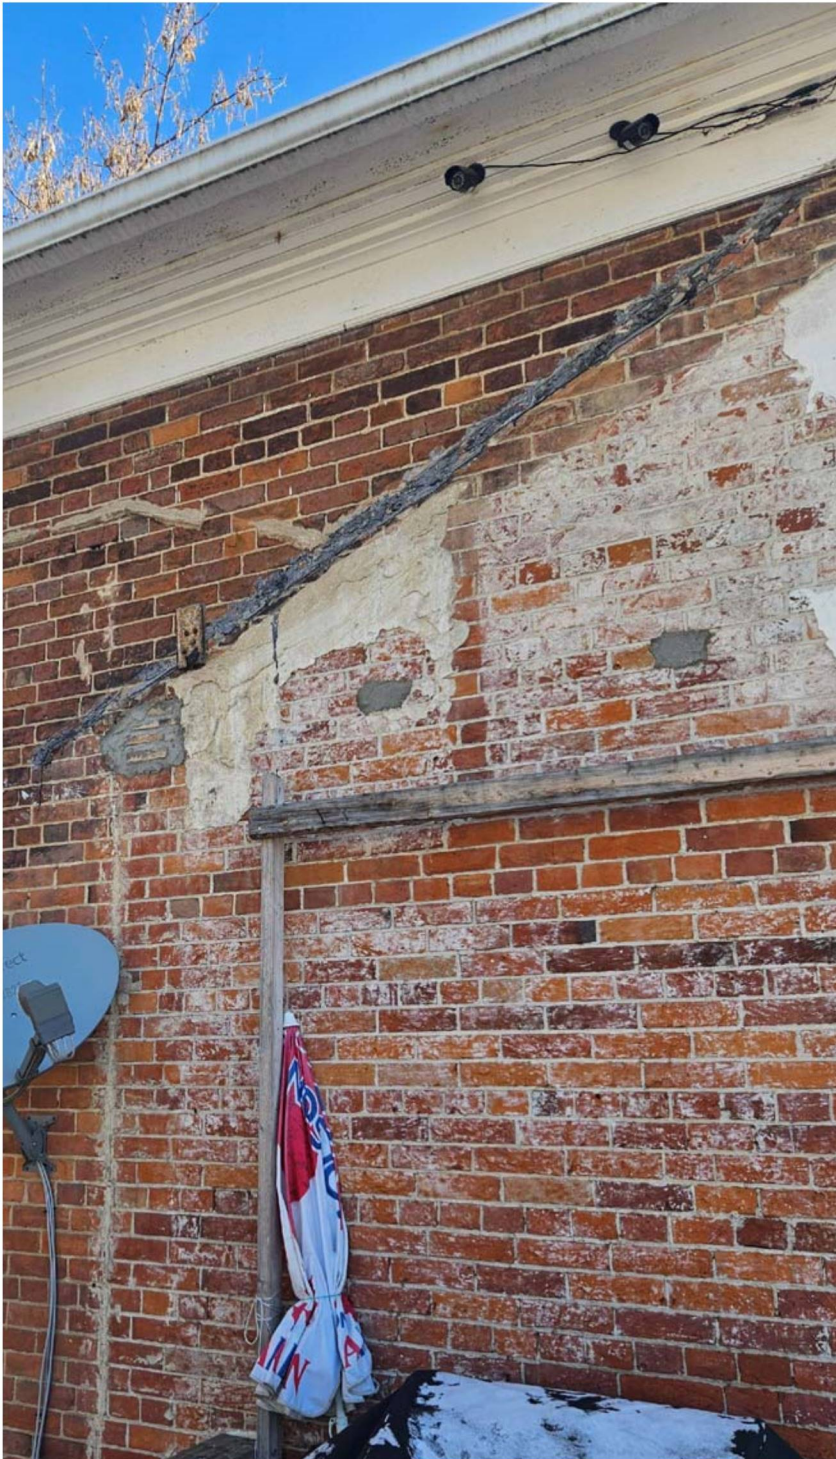
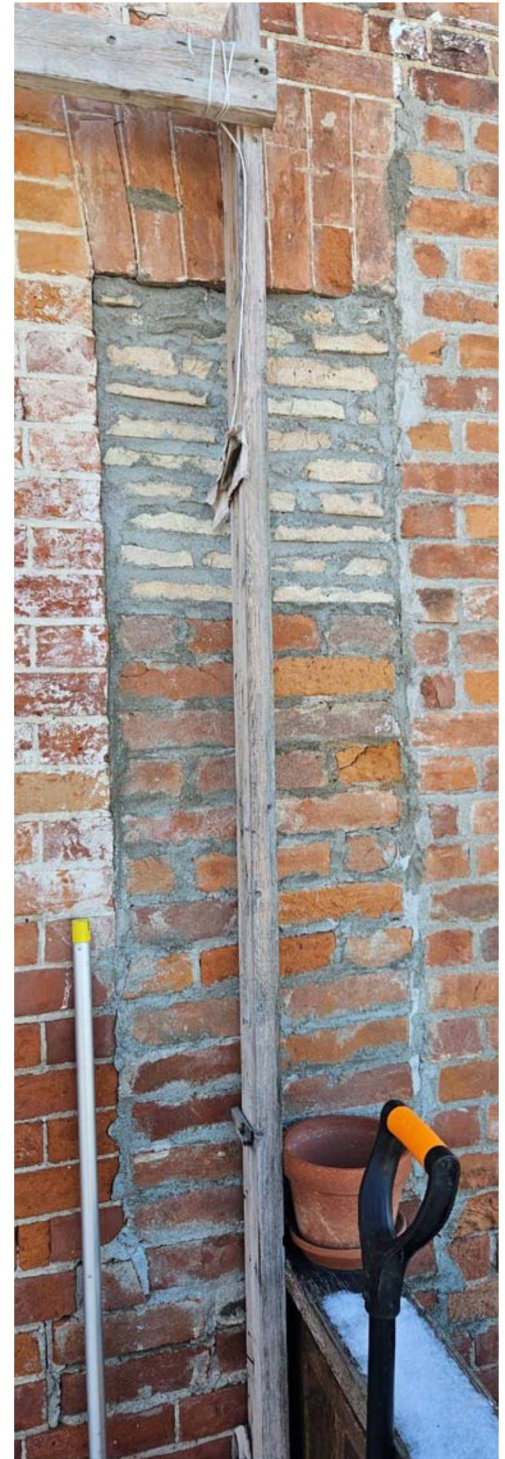
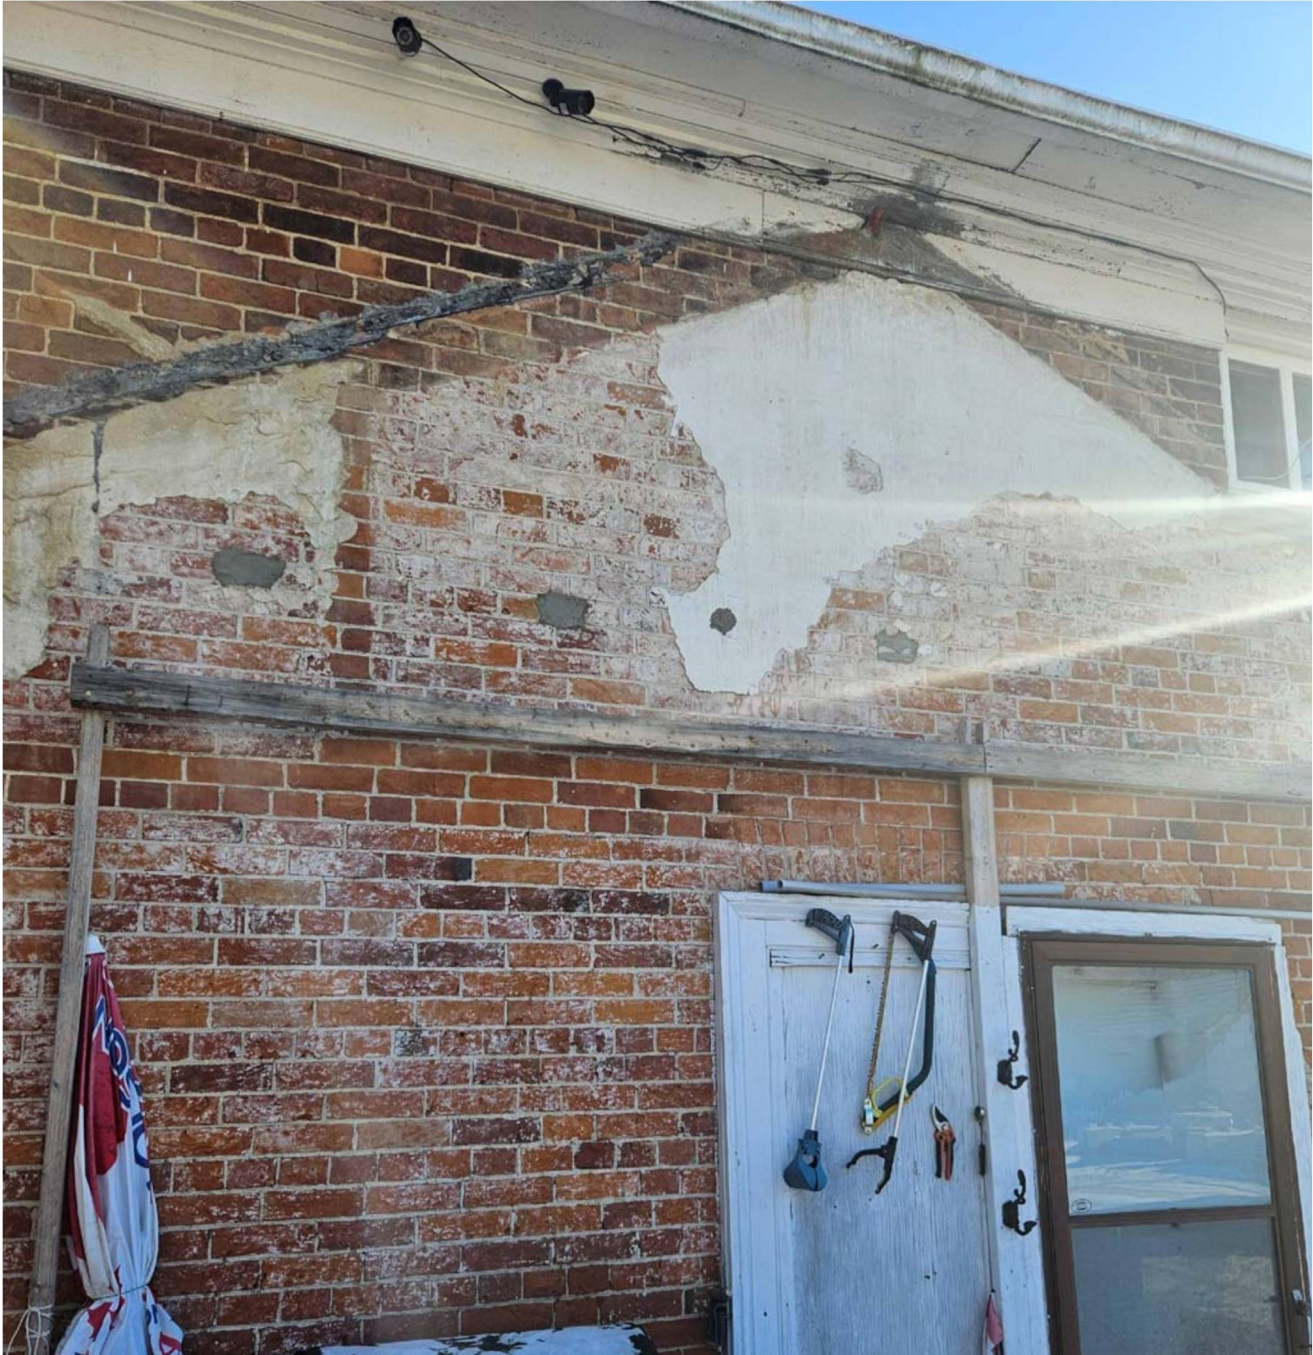
### Damage from removal of addition

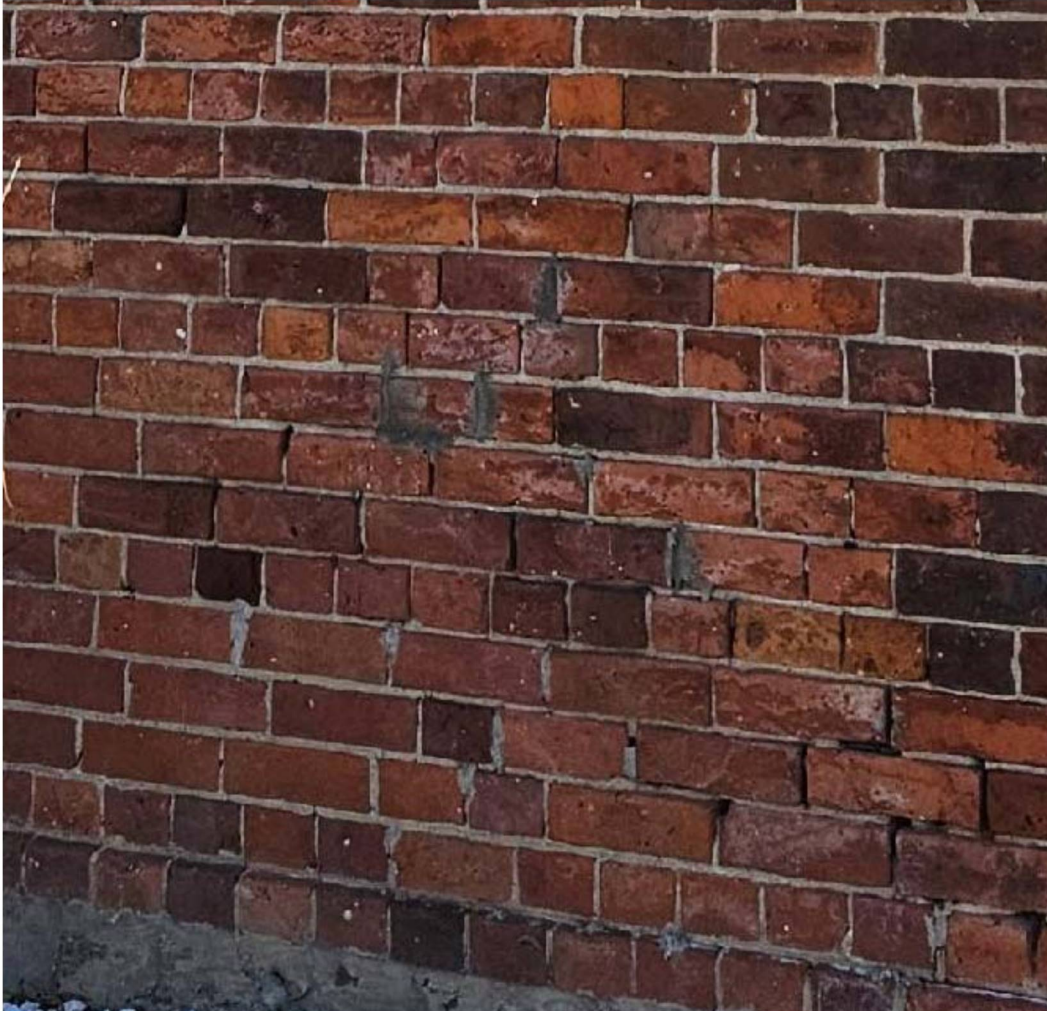
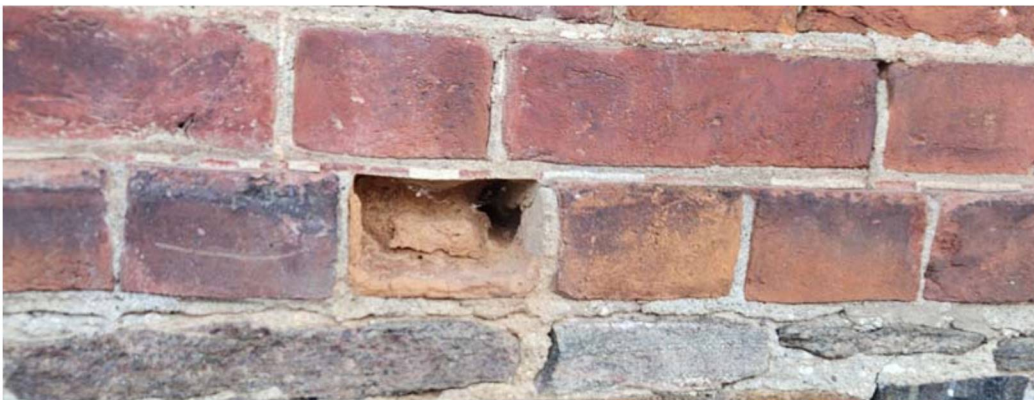
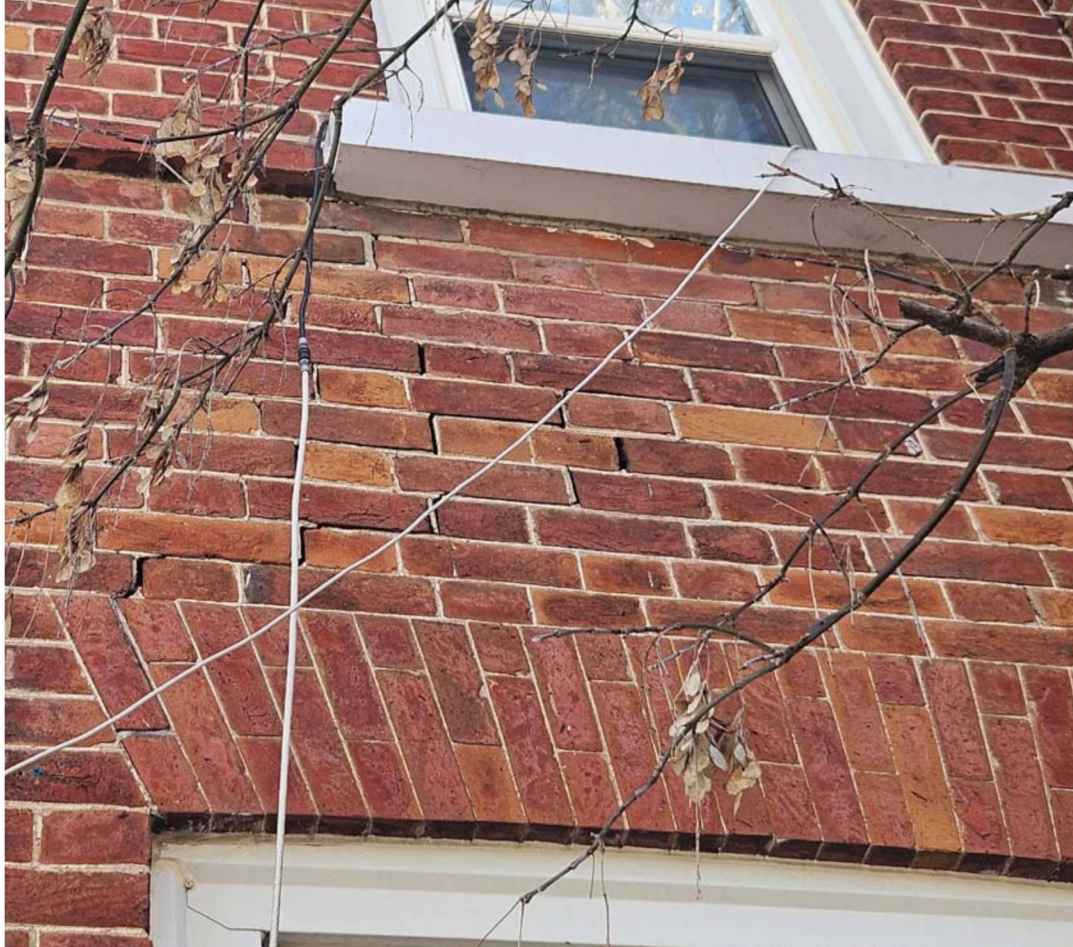
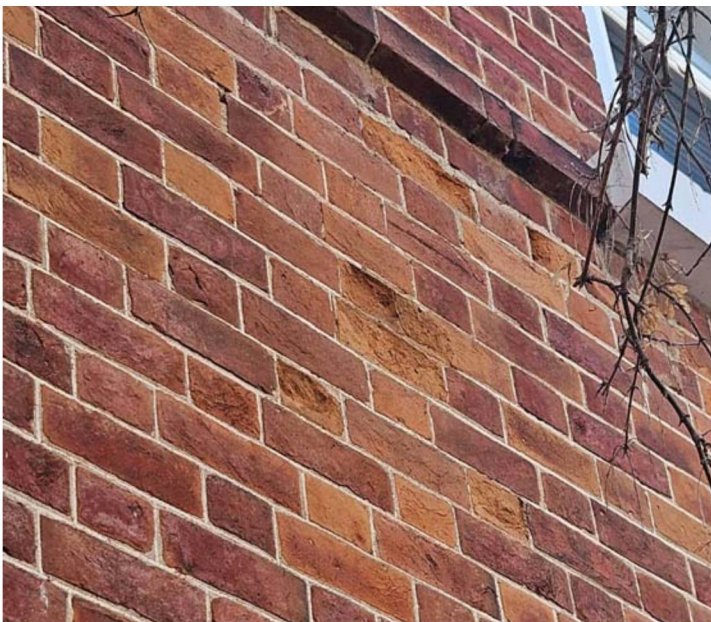
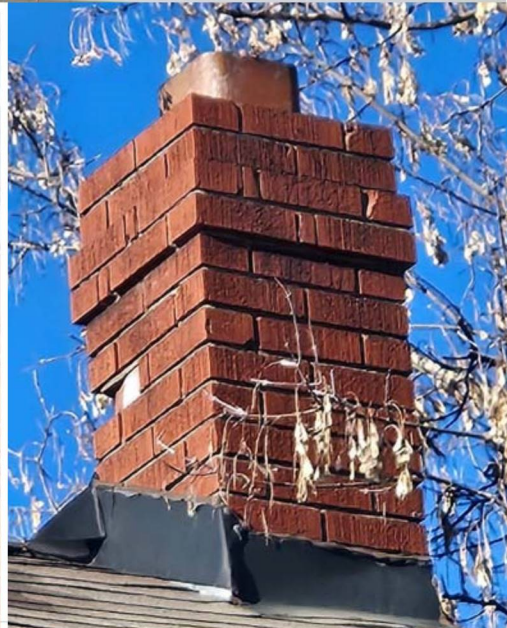
1. Spalling of the exterior veneer and cracking of joints are a result of weathering, water exposure, and improper maintenance allowing water to enter the building envelope.
2. Cracks visible in Soffit exposing the wooden elements to water damage and potential further deterioration.
3. The ceiling has cracked and deflected in multiple sections throughout dwelling, and creating a serious safety hazard.
4. The dwelling does not have proper roof ventilation, which is a requirement under the Ontario Building Code (OBC). Without adequate ventilation, there is an increased risk of moisture buildup within the roof space. This could create health hazards, including mold growth, and contribute to the deterioration of structural materials.

## Spalling and cracking Veneer

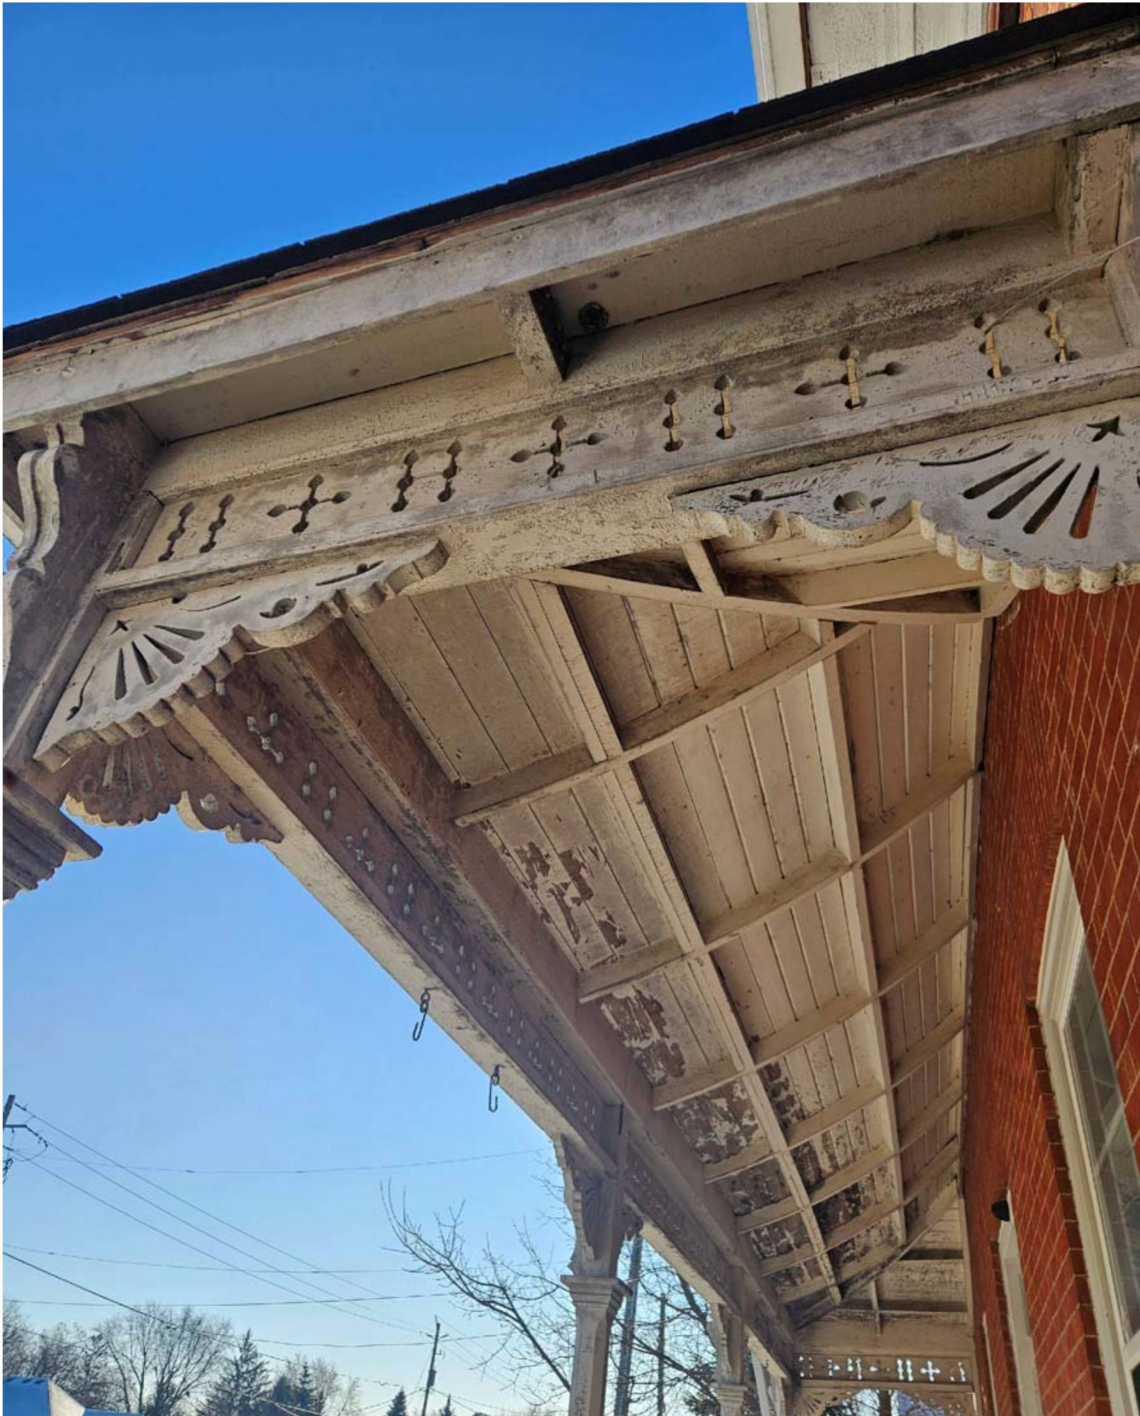
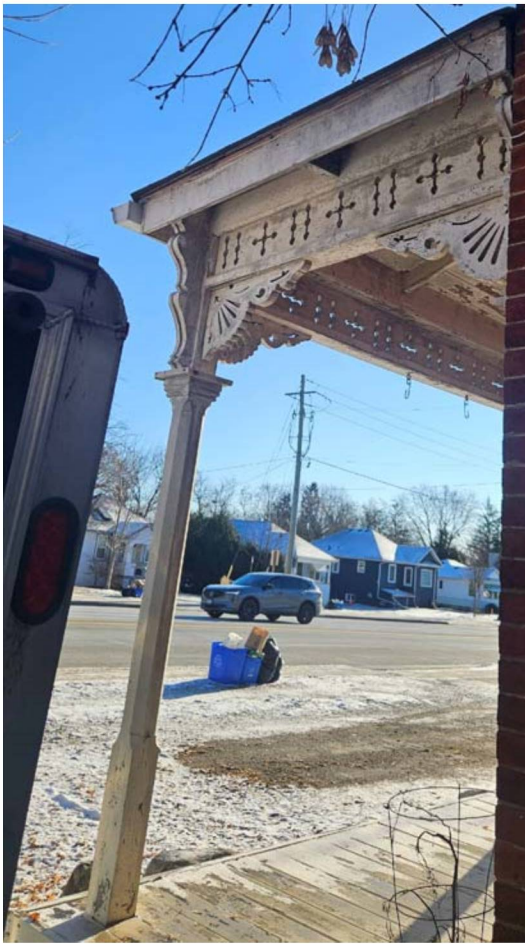
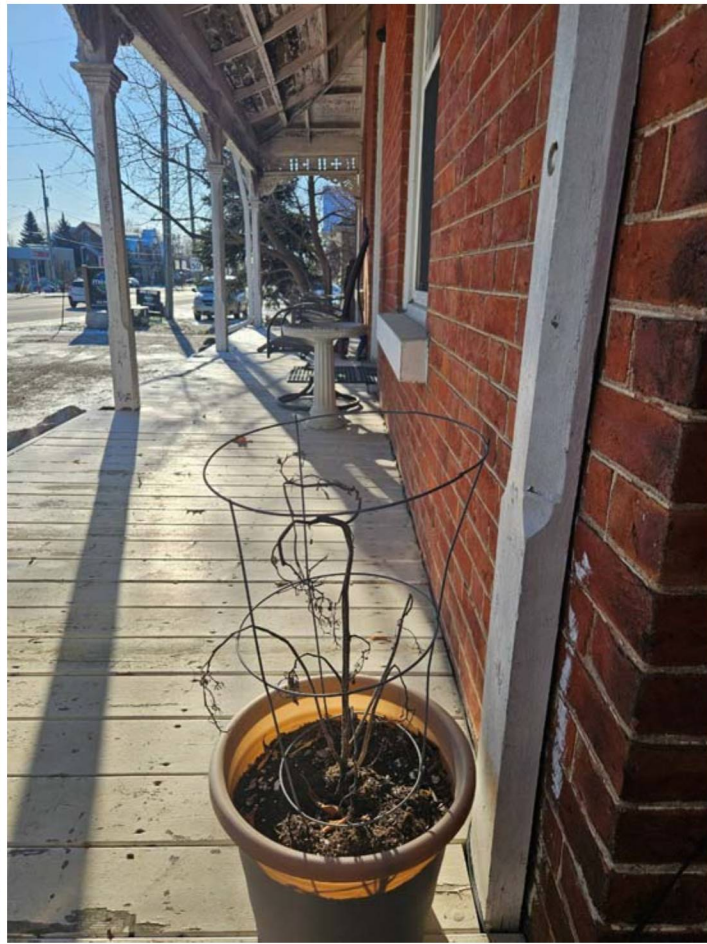
## Porch

8. The top of the roof appears to be deflected when observed from a distance.
9. The porch is lacking proper foundations or footings, which raises concerns about the stability.

10. Deflection and cracking in the ceiling suggest structural instability
11. The railings are too low posing a safety risk and do not meet code requirements
