**Heritage Permit Application File #: HP-25-02**  
**13760 Keele Street - Marylake Gatehouse**

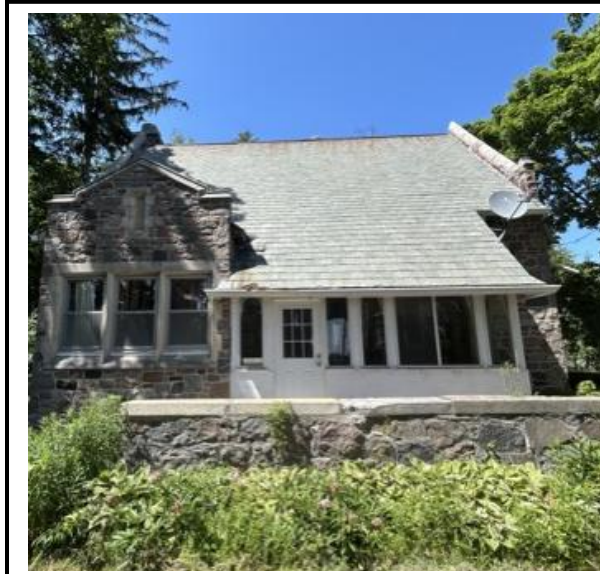
**Photo #1:** South facing elevation of gatehouse. Staff note the screened front porch, and windows are not original to the structure.

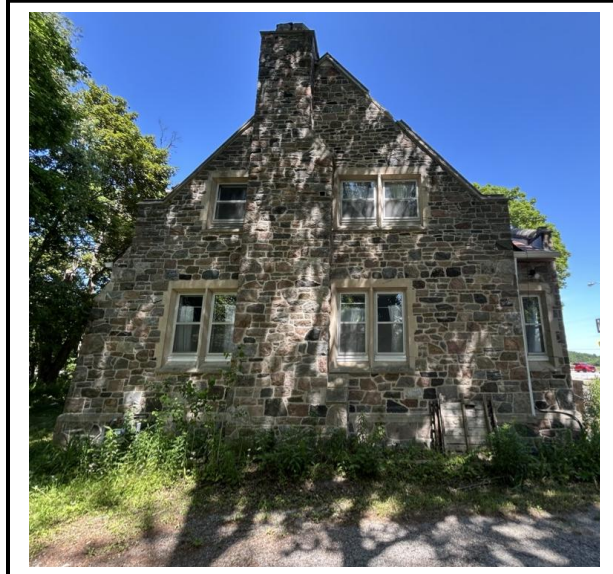
**Photo #2:** West facing elevation of gatehouse. Staff note the damaged ridge cap along the gable.

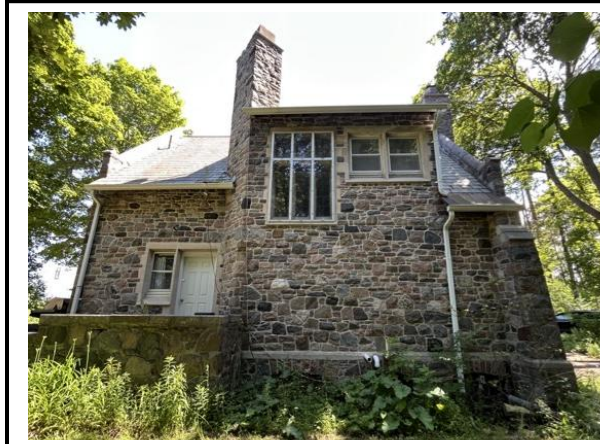
**Photo #3:** North facing elevation of gatehouse. Staff note the windows and door are not original to the structure. Staff also note missing slate shingles on the west side of roof.

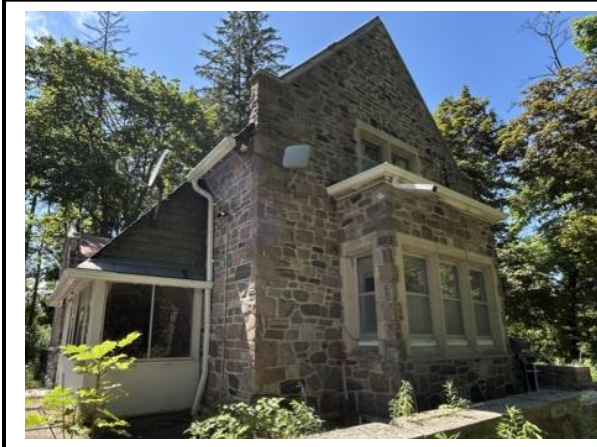
**Photo #5:** Photo taken facing northwest. Staff note the screened porch as not being original to the structure.

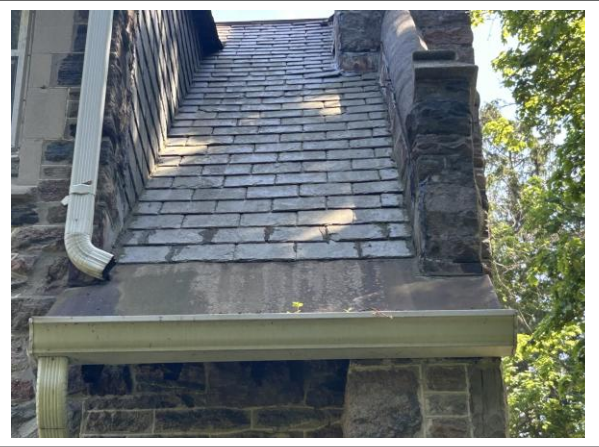
**Photo #6:** A closer photo of the missing shingles also seen in Photo 3. Staff note the deterioration of remaining shingles.

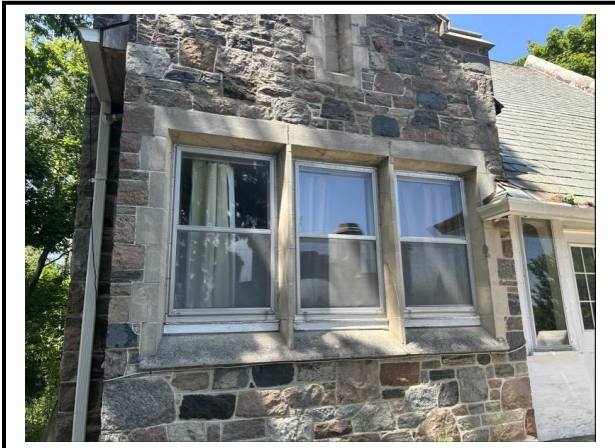
**Photo #7:** Windows on south facing elevation of gatehouse. Staff note the existing window openings will not be altered, and the proposed windows will be retrofitted into the existing openings.
