Listed Demolition Application
342 Kettleby Road

Photo #1: South facing elevation of subject structure. Staff note the damaged roof, in which a hole is visible beneath the east chimney. Staff also note the rotting/decaying shingles.

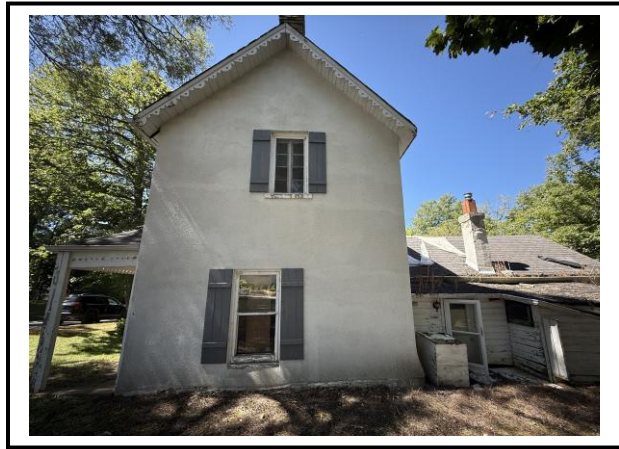
Photo #2: East facing elevation of subject structure. Staff note the rotting/decaying state of the window frames and sills.

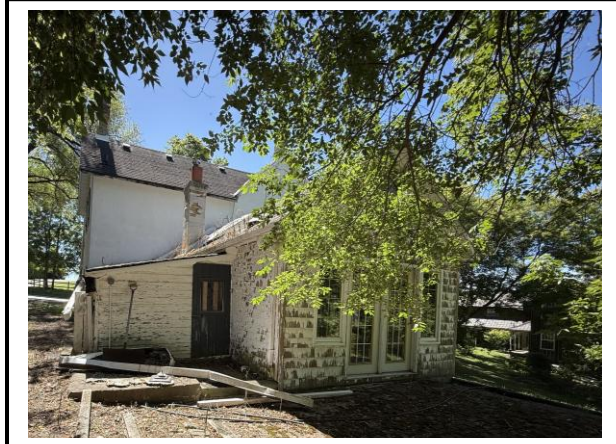
Photo #3: North facing elevation of subject structure. Staff note extensive deterioration of the rear addition.

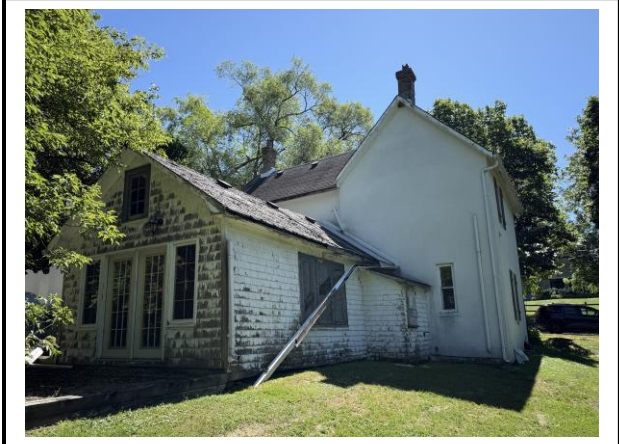
Photo #4: West facing elevation of subject structure. Staff note extensive deterioration of the rear addition.

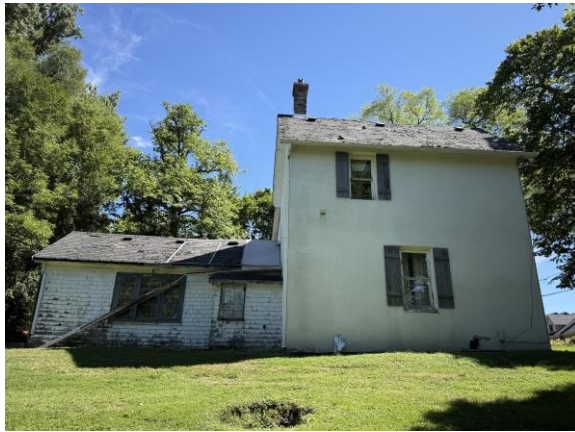
Photo #5: West facing elevation of the subject structure. Staff note the deterioration of the rear addition, including the roof and its elements.

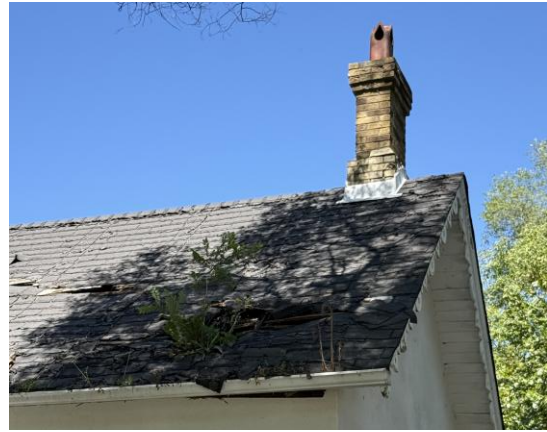
Photo #6: A closer photo of the hole in the roof, also seen in Photo 1. Staff note the deterioration of the remaining shingles and the vegetative growth.

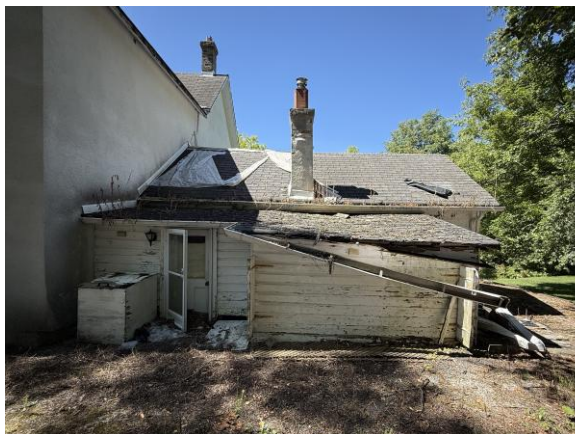
Photo #7: Closer image of east elevation of rear addition. Staff note the significant deterioration and damage to this element of the structure.

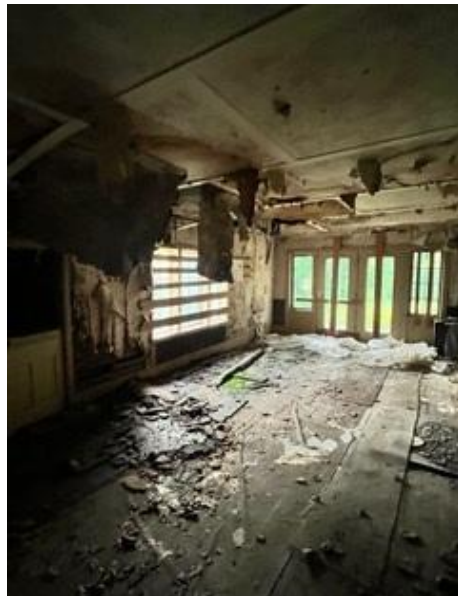
Photo #8: Images of the interior provided by the applicant. Staff did not enter the structure due to safety concerns.
