**Heritage Permit Application File #: HP-25-03  
19 Old King Road – Nobleton Community Hall**

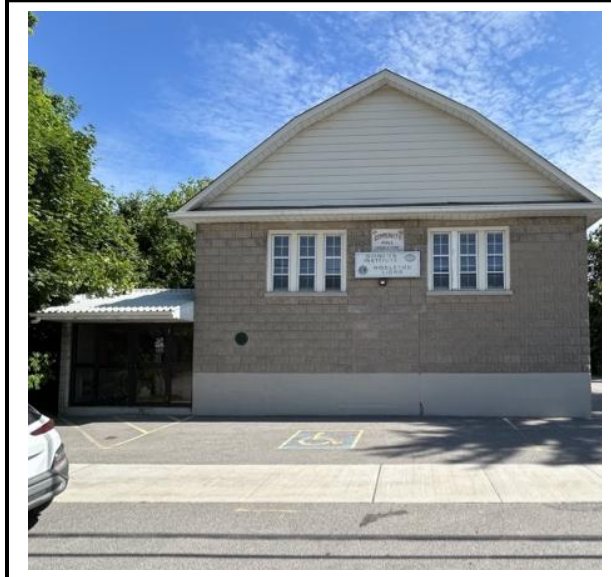
**Photo #1:** North facing elevation of Nobleton Community Hall. Staff note the existing signage affixed to the façade, which is not a heritage attribute, is to be removed from the façade but retained in some fashion (relocated to the interior, etc.)

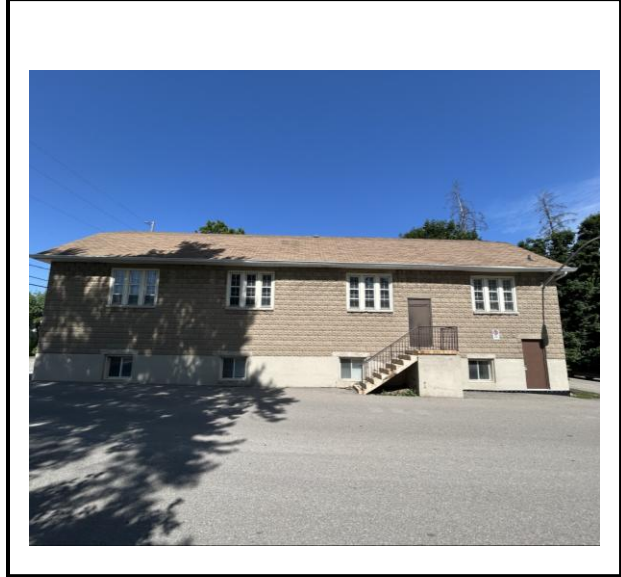
**Photo #2:** West facing elevation of Nobleton Community Hall. Staff note the staircase and doorway shown in this image are proposed to be replaced and enlarged, respectfully.

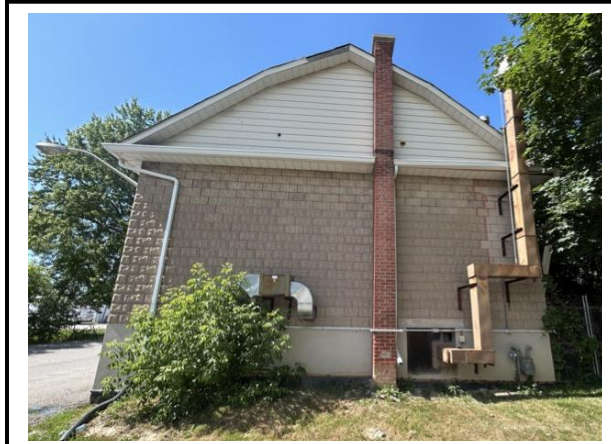
**Photo #3:** South facing elevation of Nobleton Community Hall. Staff note the existing ventilation ducting is proposed to be removed/relocated.

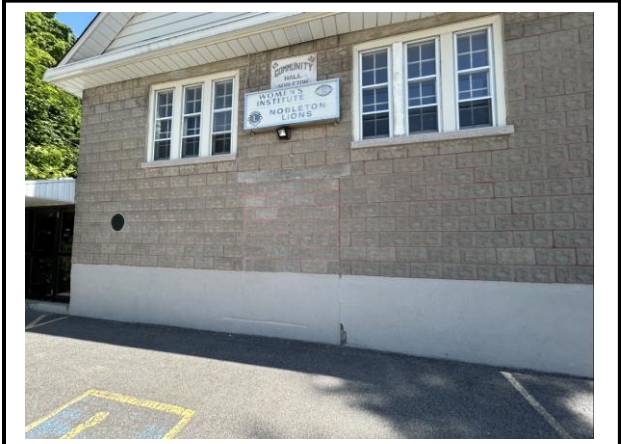
**Photo #4:** Closer photograph of North facing façade. Staff note damaged portions of the façade that are proposed to be restored.
